Revised
FULL RESERVE STUDY
Armfield Farm
Homeowners Association

Chantilly, Virginia

Inspected - September 13, 2018

Revised - January 18, 2019

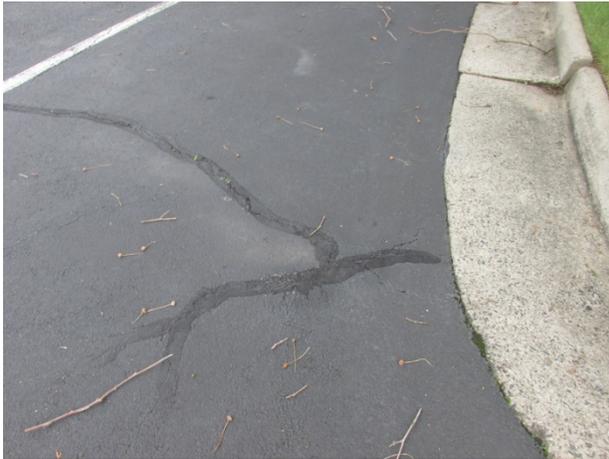
Condition: Good to fair overall with cracks and previous repairs evident

Previous repairs evident

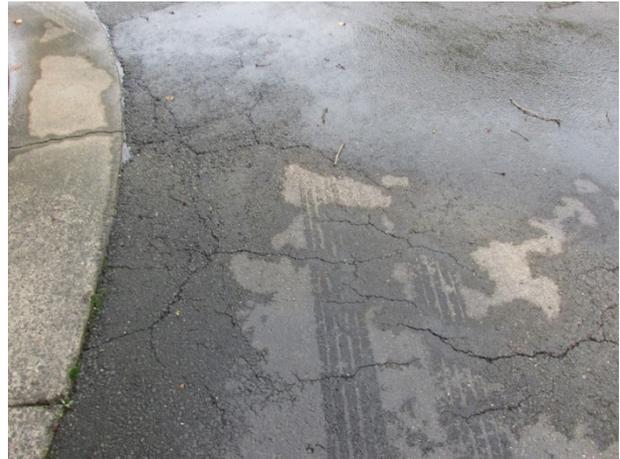
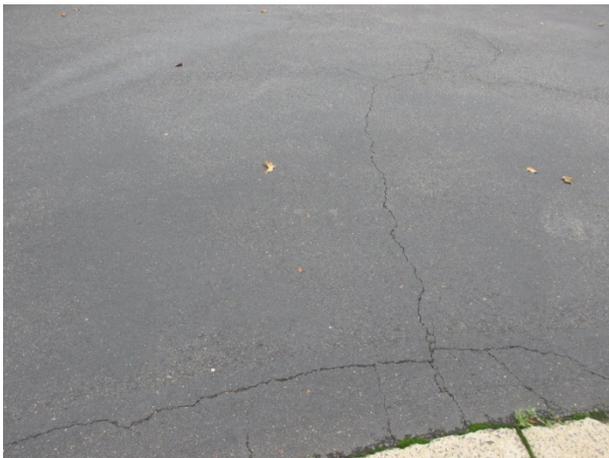
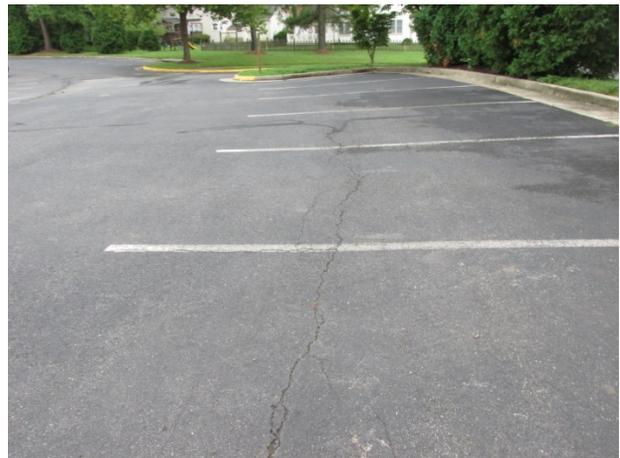
Pavement cracks

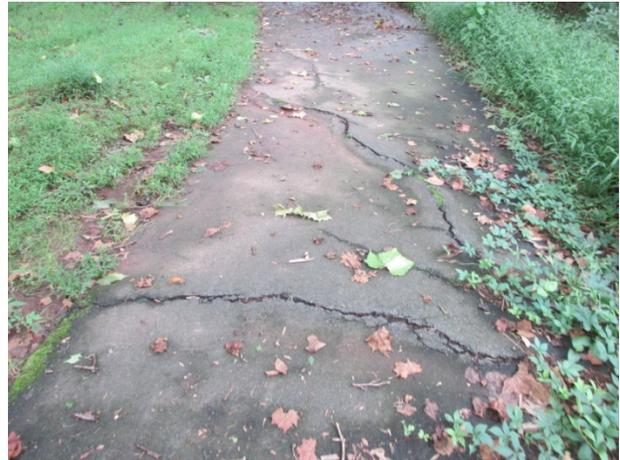
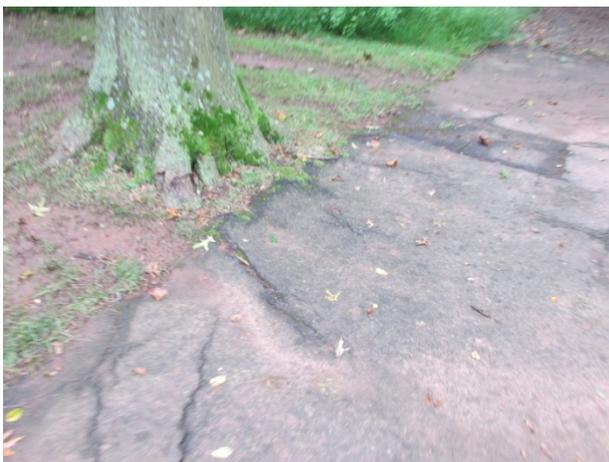
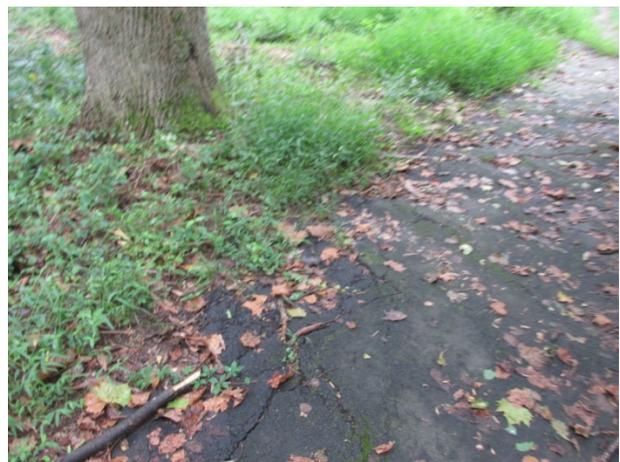
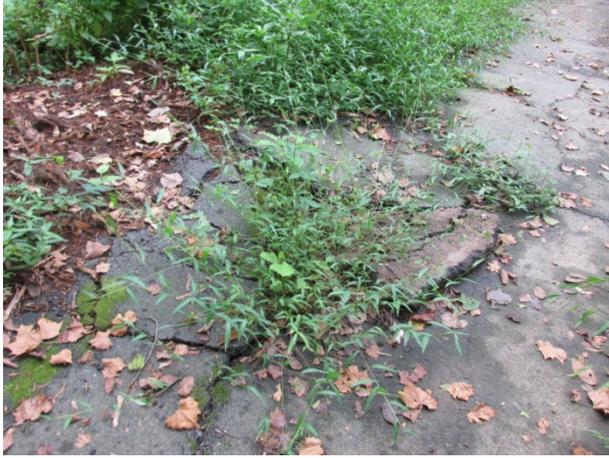
Condition: The paths at Clary Sage Road are in poor condition with extensive cracking and heave evident. The remaining paths are in good to fair overall condition with minor cracking evident.

Cracks and heave at Clary Sage path

- Replacement of the remaining walking paths
- Replacement of the basketball courts at Beach Down Drive
- Replacement of the light poles and fixtures at the tennis courts
- Replacement of the doors at the pool house

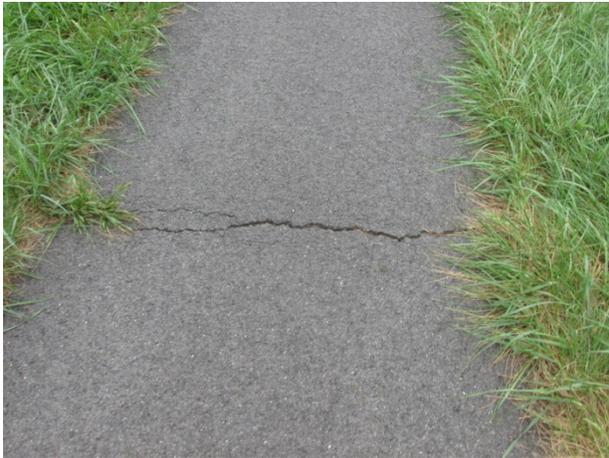
Pavement crack

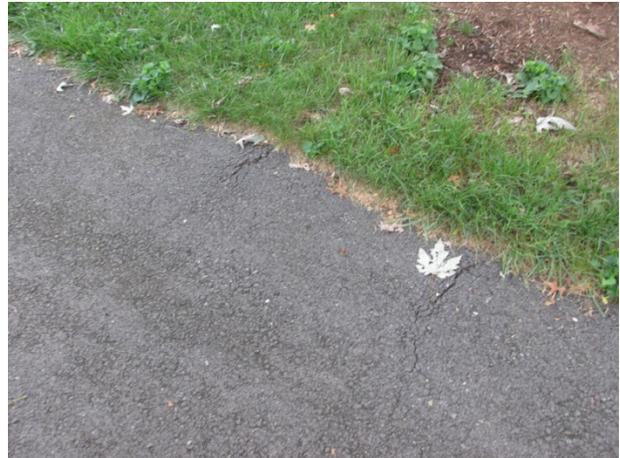
Minor edge cracks

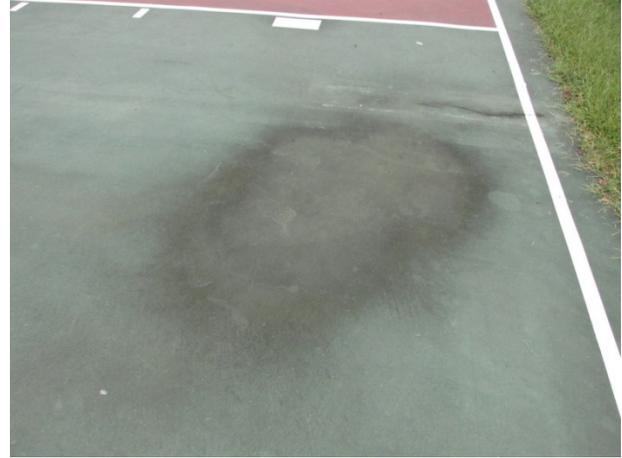
Condition: Fair overall with surface stains

Surface stain

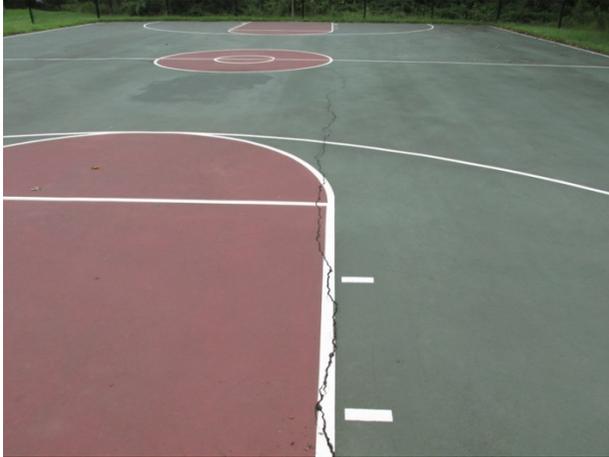
Condition: The court at Springhaven Drive is in good to fair overall condition with cracks evident. The courts at Beach Down Drive are in poor overall condition with extensive cracking evident.

Crack at Springhaven Drive court

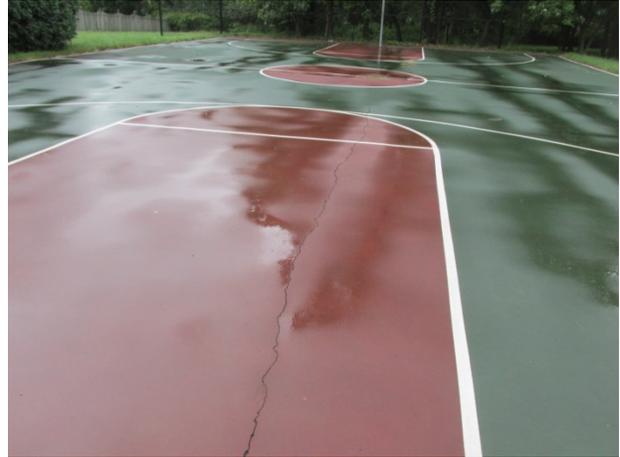
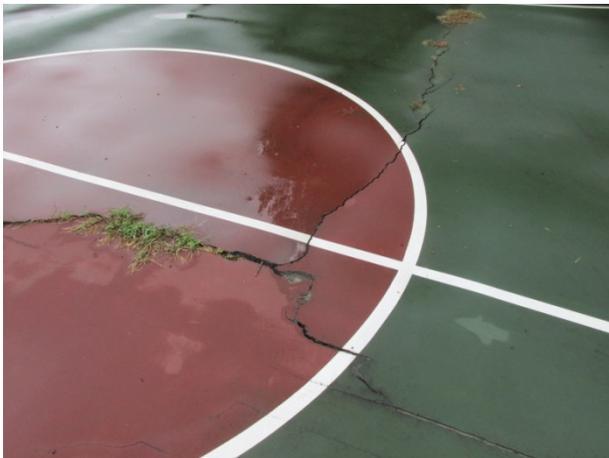
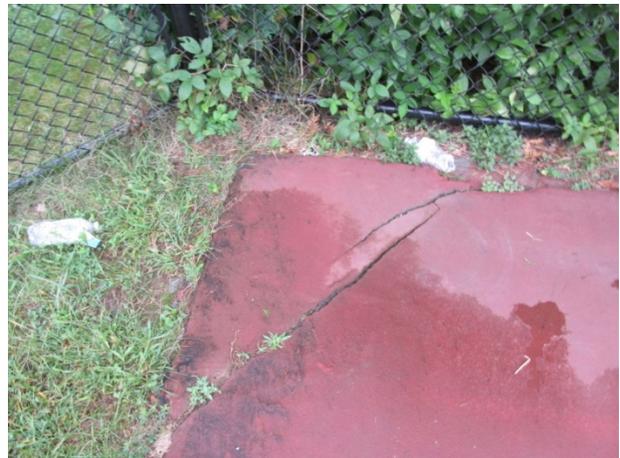
Cracks at Beach Down Drive court

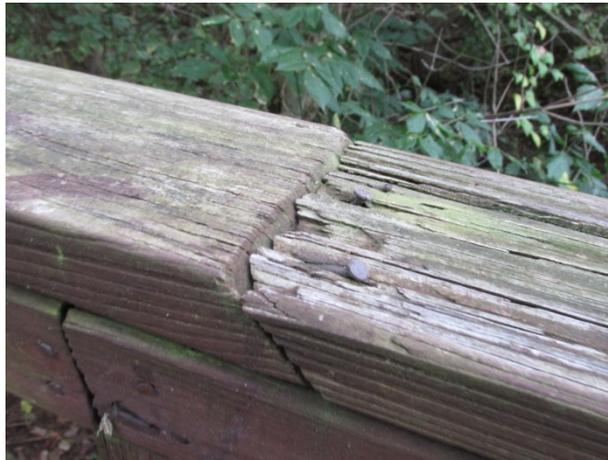
Condition: Fair overall condition with nail pop and wood deterioration evident

Nail pop and wood deterioration

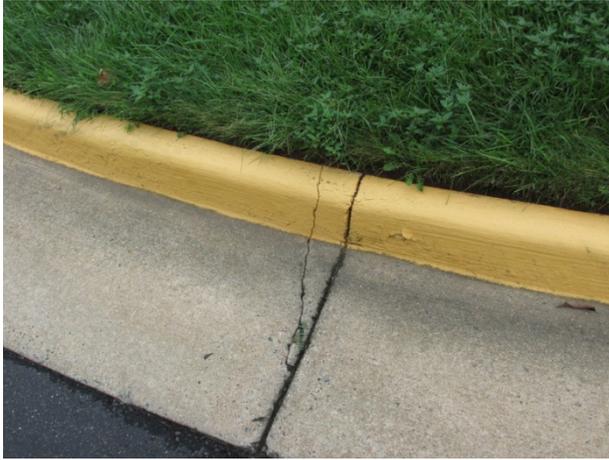
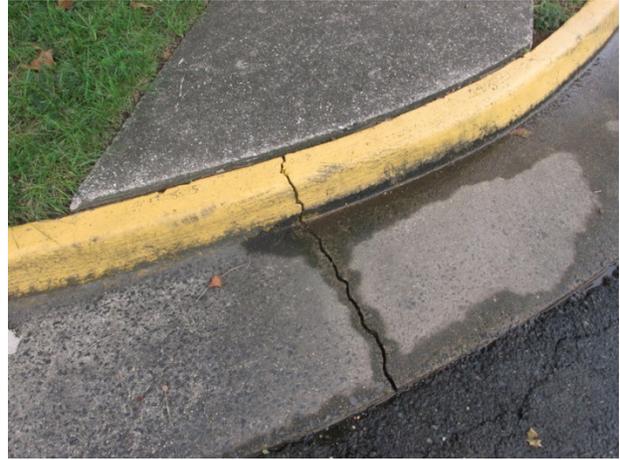
Condition: Good to fair overall with cracks and heave evident

Curb and gutter crack

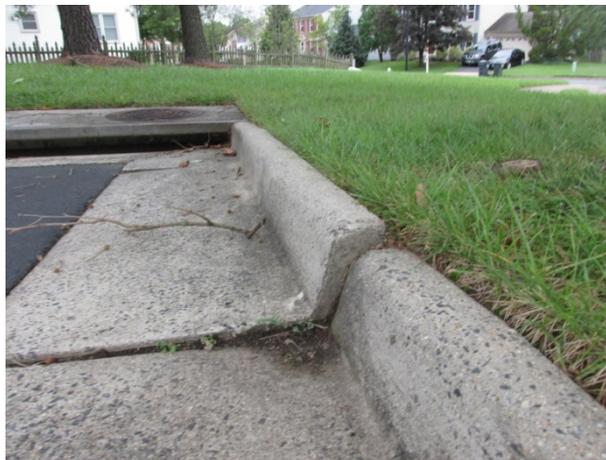
Curb and gutter heave

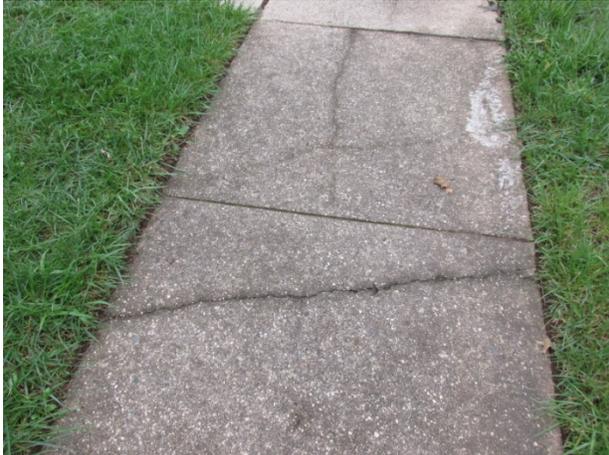
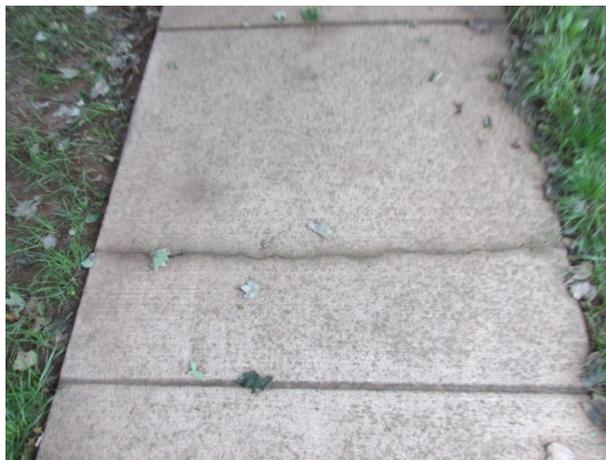
Condition: Varying from good to fair overall with cracks and trip hazards evident

Sidewalk cracks

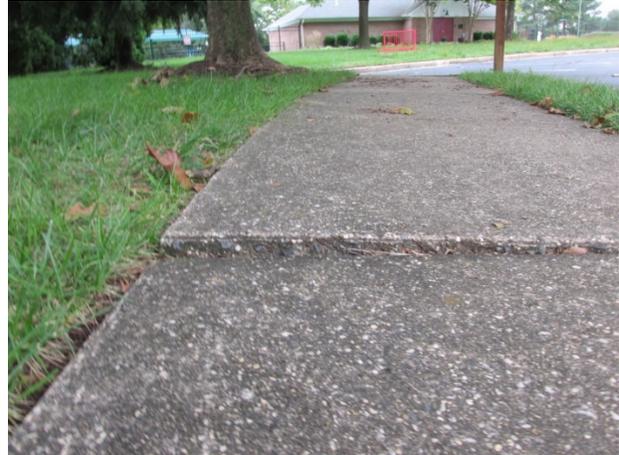
Trip hazard

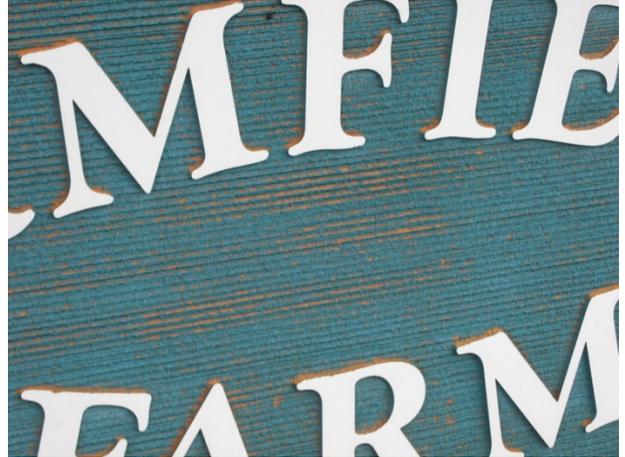
Finish deterioration

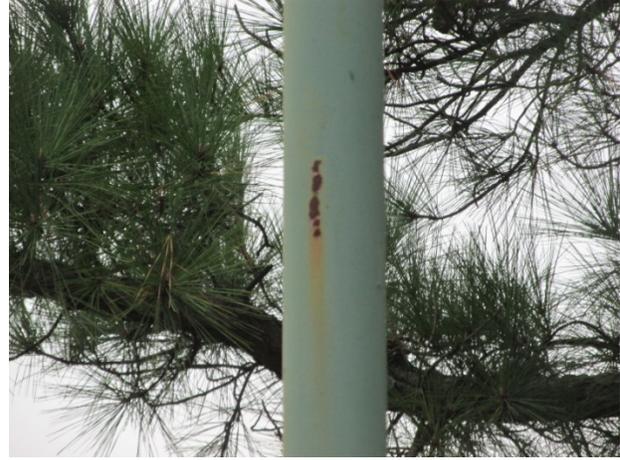
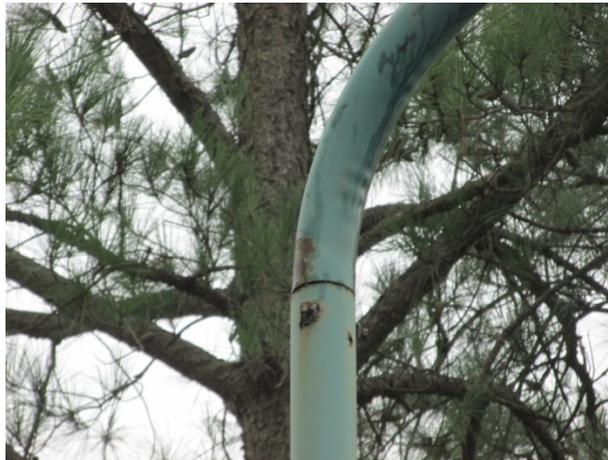
Condition: Fair overall with rust and finish deterioration evident

Rust and finish deterioration

History: Original. Management informs us the Association plans to replace the fixtures with LED (light-emitting diode) fixtures at the time of replacement.

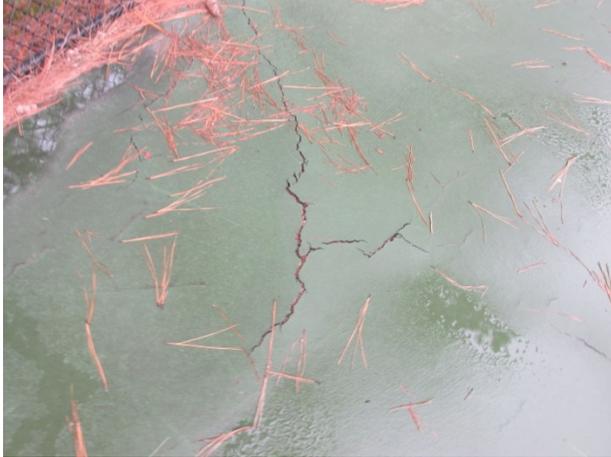
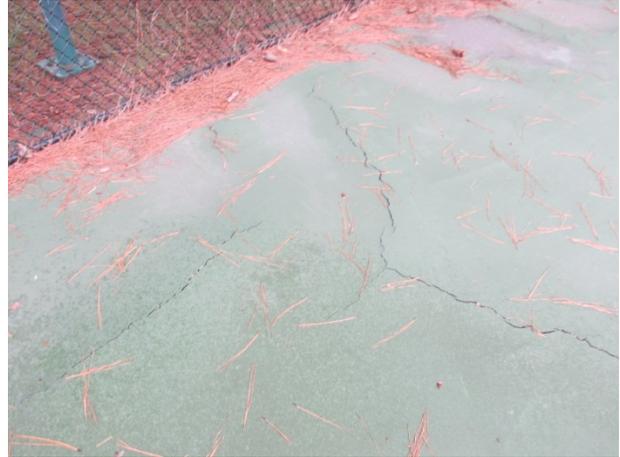
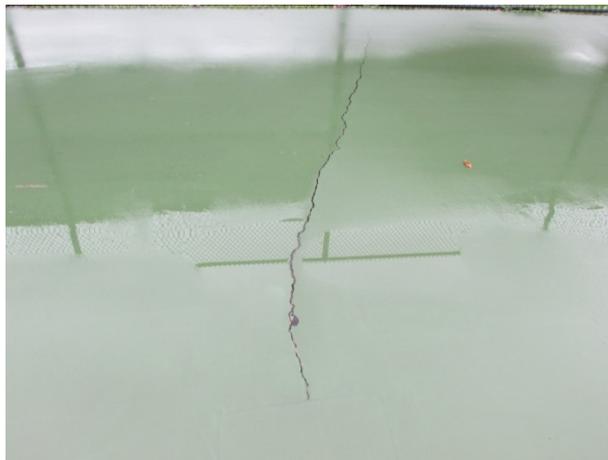
Condition: Good to fair overall with minor surface cracks evident

Surface cracks

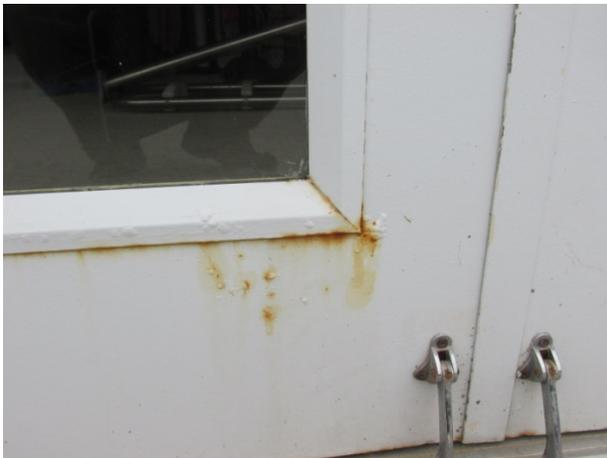
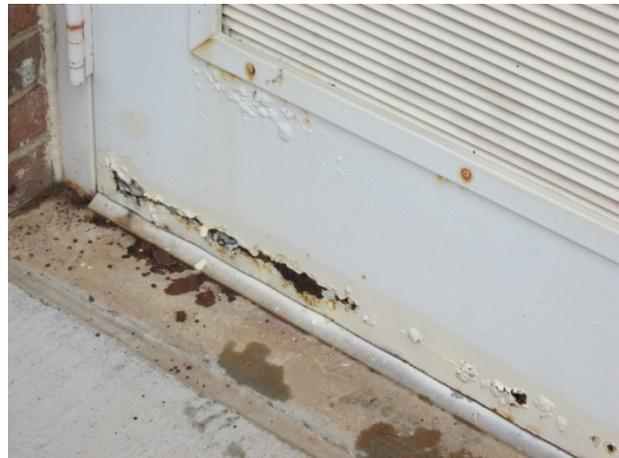
Condition: Fair overall condition with rust evident. Management informs us the Association plans to replace the doors in the near term.

Rust
