Armfield Farm

Homeowners Association

September 20, 2023 • Chantilly, VA

RESERVE STUDY

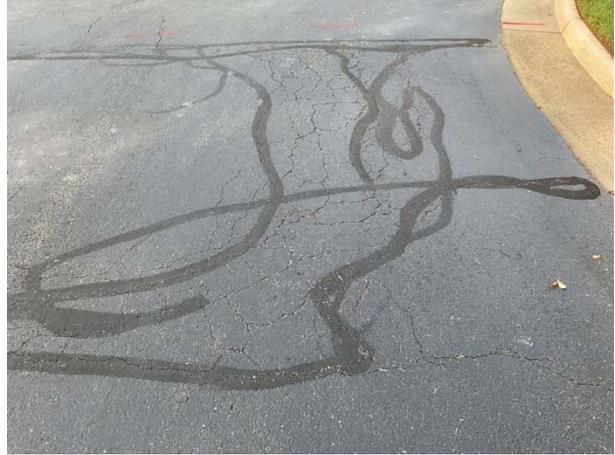
Cracks and repairs

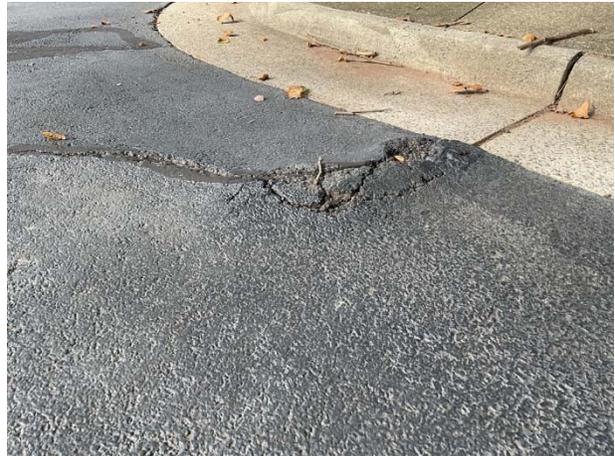
Root intrusion

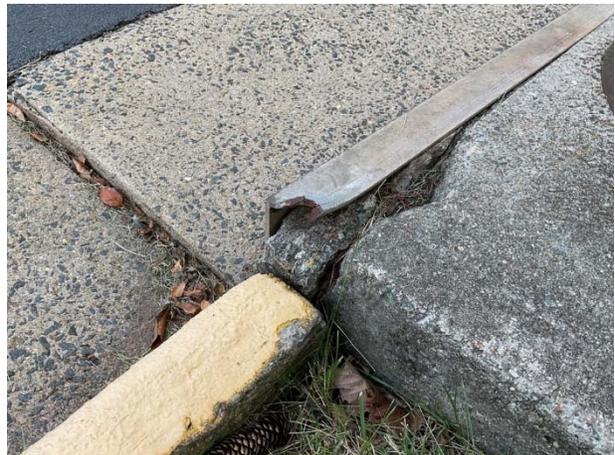
Concrete and collar damage – Note: catch basin

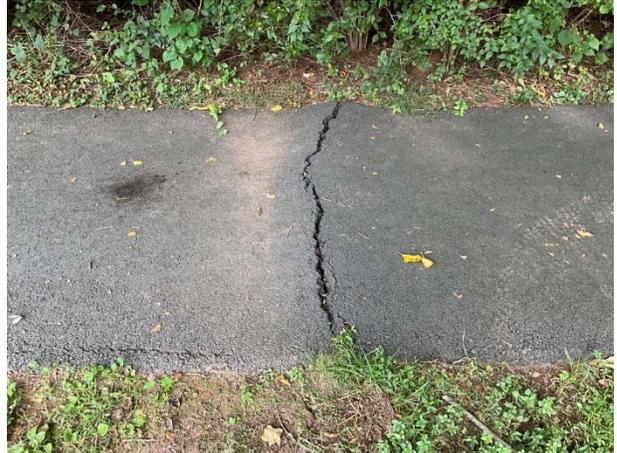
Asphalt cracks – Note: adjacent to soccer field

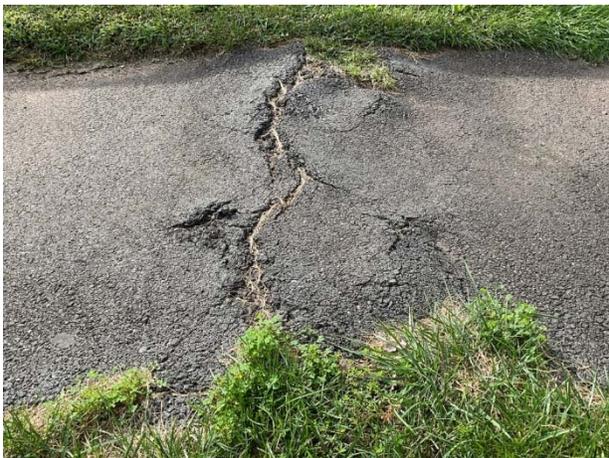
Root intrusion – Note: adjacent to Beech Down Drive basketball court

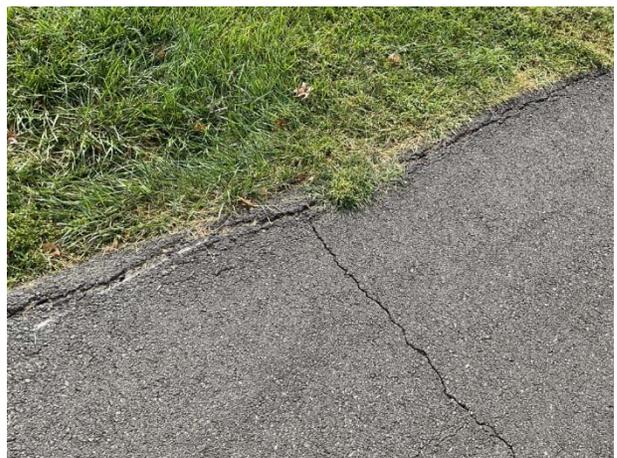
Edge deterioration

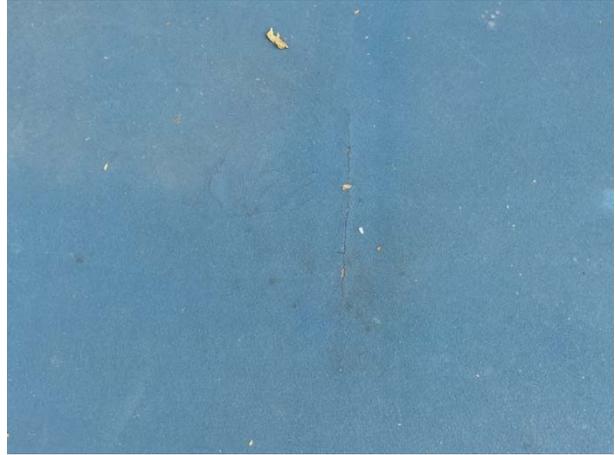
Surface crack – Note: *Beach Down Drive*

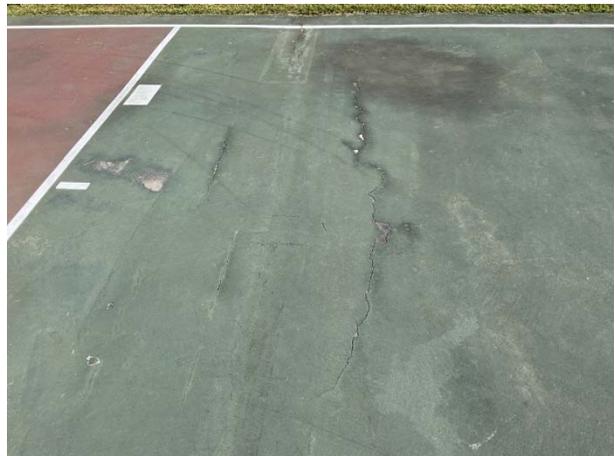
Surface deterioration and cracks

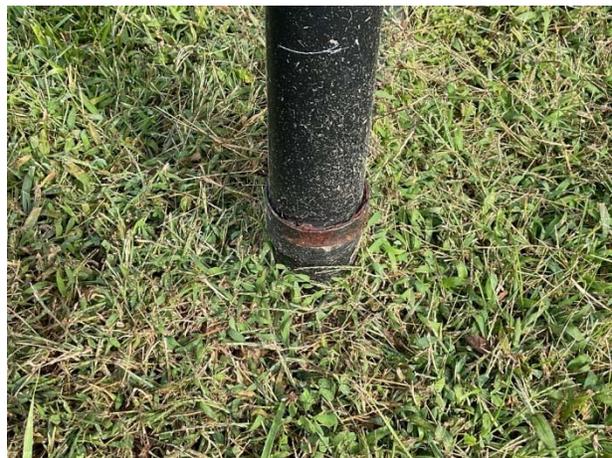
Fence rust

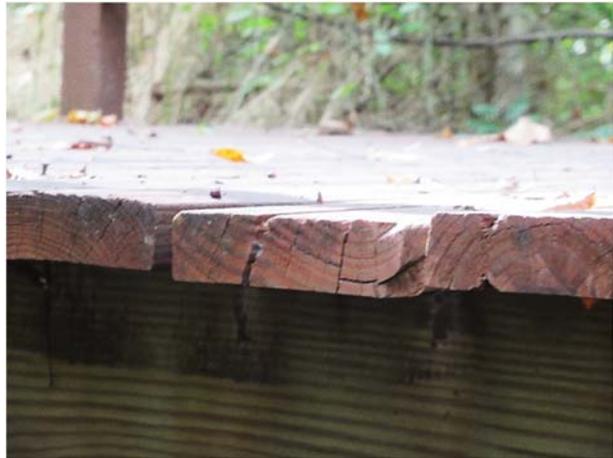
Wood split and damage

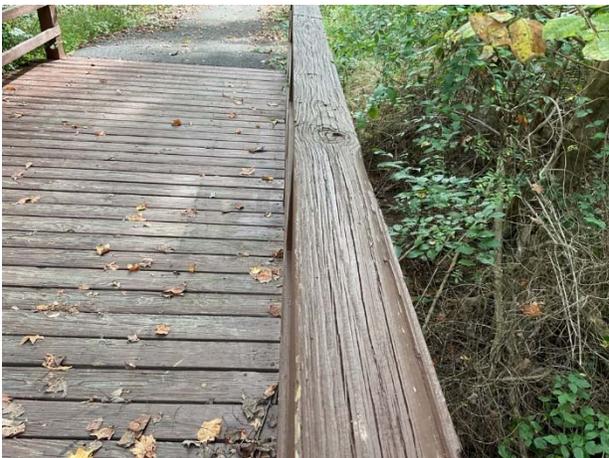
Wood deterioration

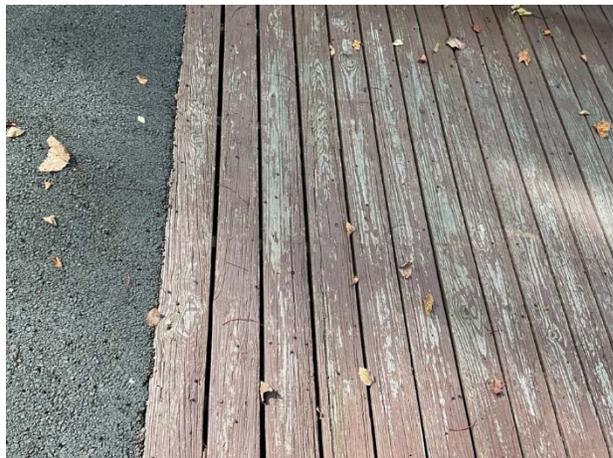
Paint deterioration

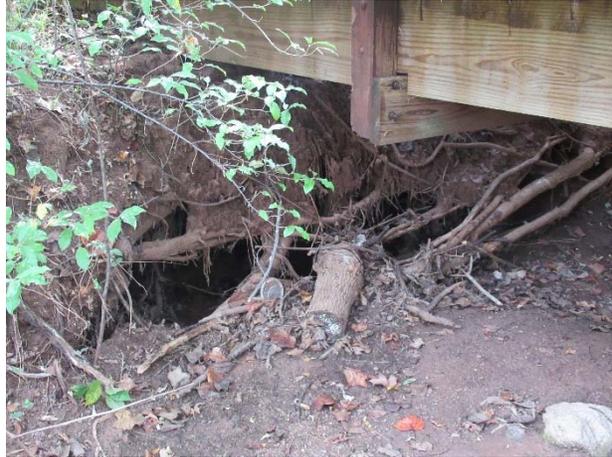
Condition: Fair overall with wood split, damage, deterioration, loose boards and erosion evident. We recommend conducting further inspections in the near term to ensure erosion is not causing structural instability at the bridge.

Errosion

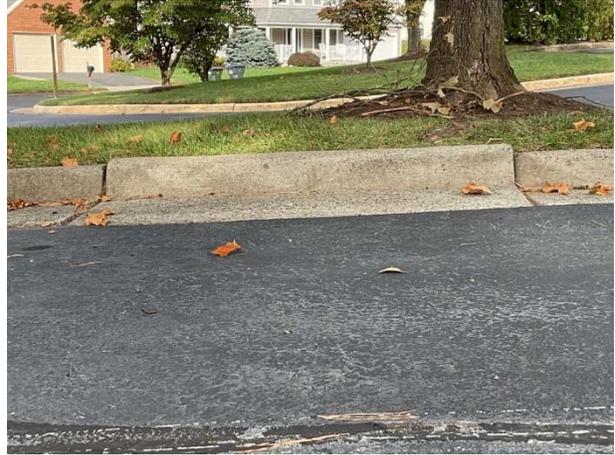
Concrete heave

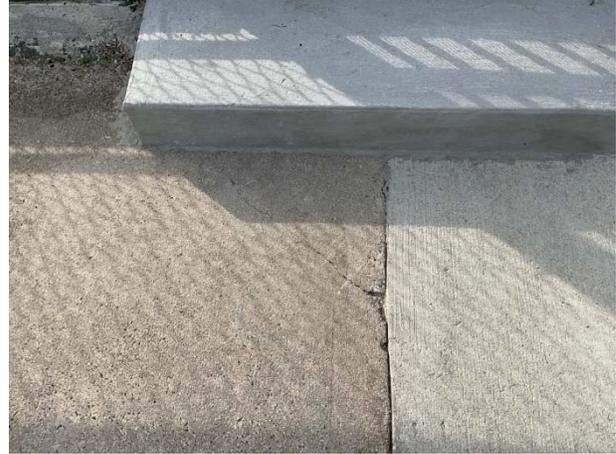
Concrete crack

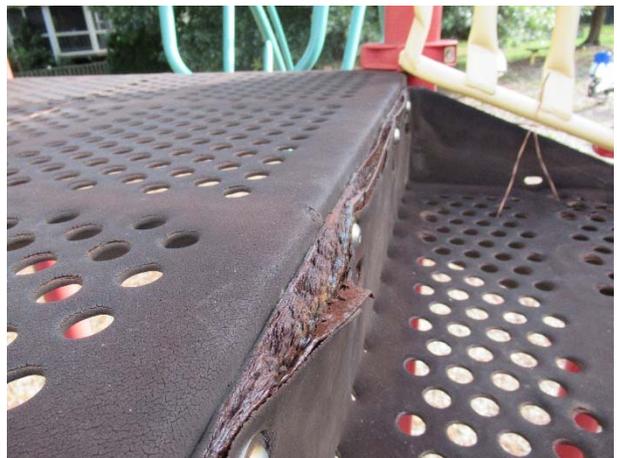
Finish deterioration and rust – Note: *pool house*

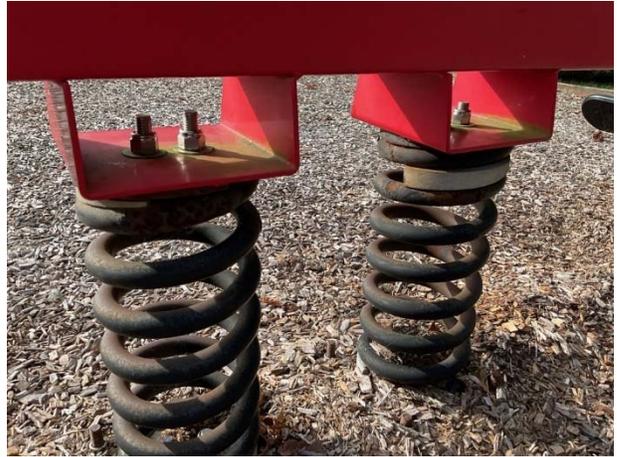
Rust – Note: pool house

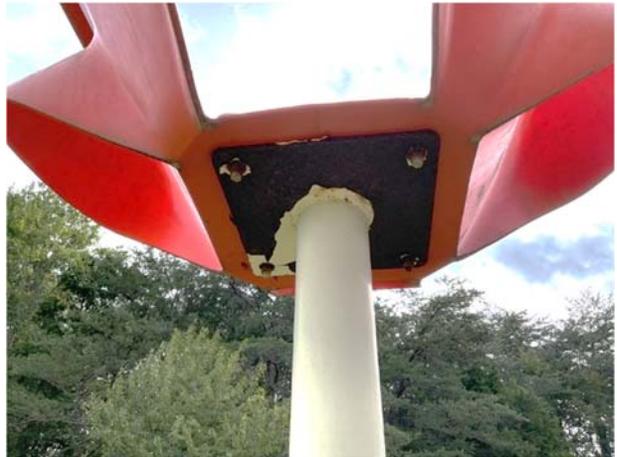
Finish deterioration and rust – Note: Clary Sage Drive

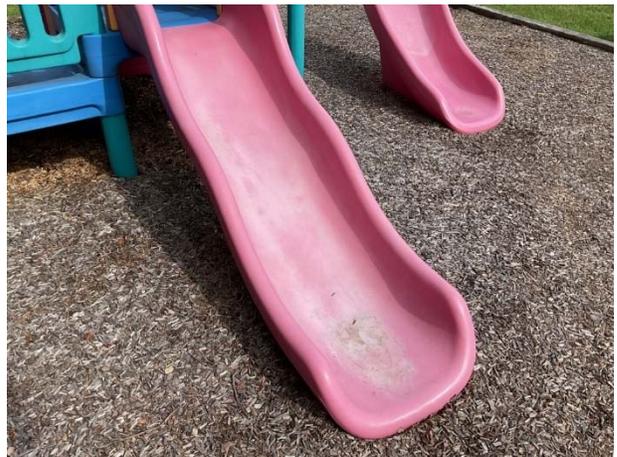
Faded equipment – Note: Clary Sage Drive

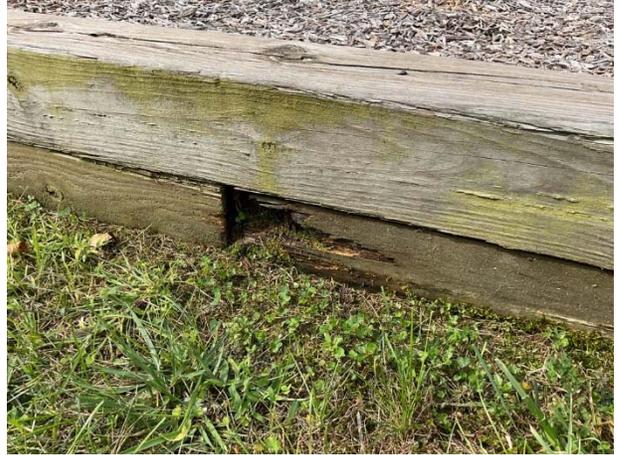
Wood deterioration – *Note: Clary Sage Drive*

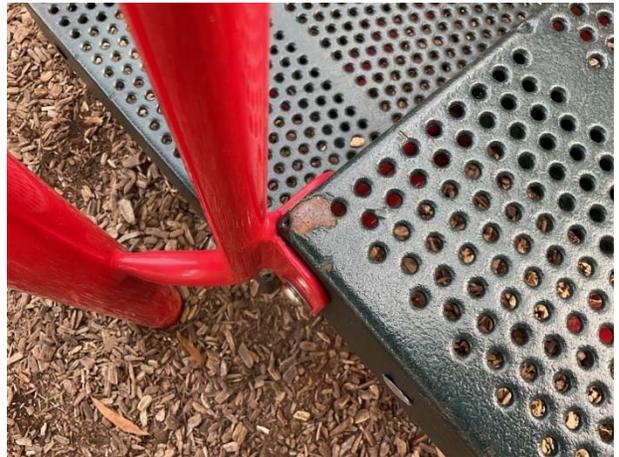
Finish deterioration and rust – *Note: Springhaven Drive, North*

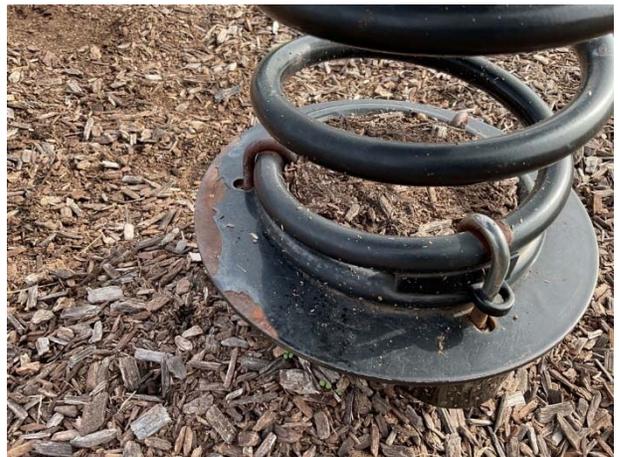
Finish deterioration and rust – *Note: Springhaven Drive, South*

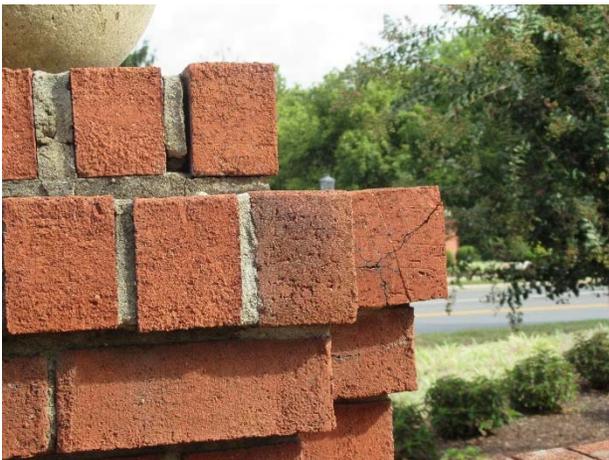
Mortar deterioration and masonry cracks– Note: Centerville Road and Armfield Farm Drive

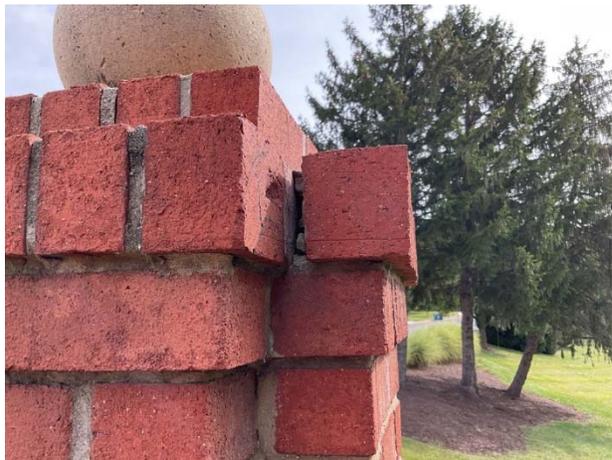
Mortar deterioration – Note: Centerville Road and Armfield Farm Drive

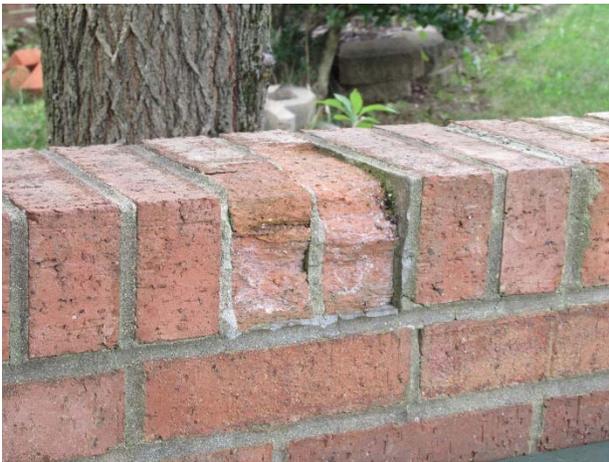
Masonry damage – Note: Bellerose Drive and Lees Corner Road

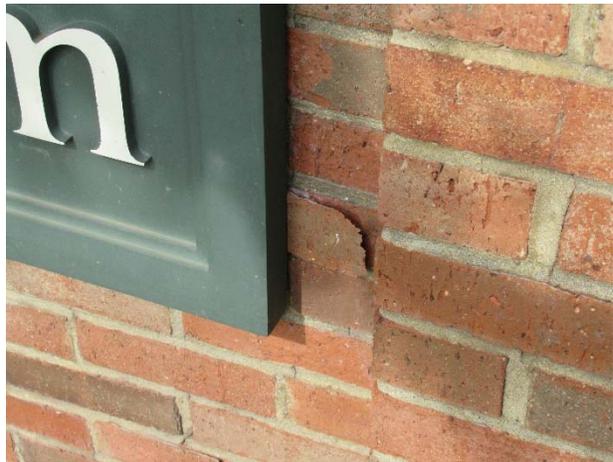
Masonry damage – Note: Bellerose Drive and Lees Corner Road

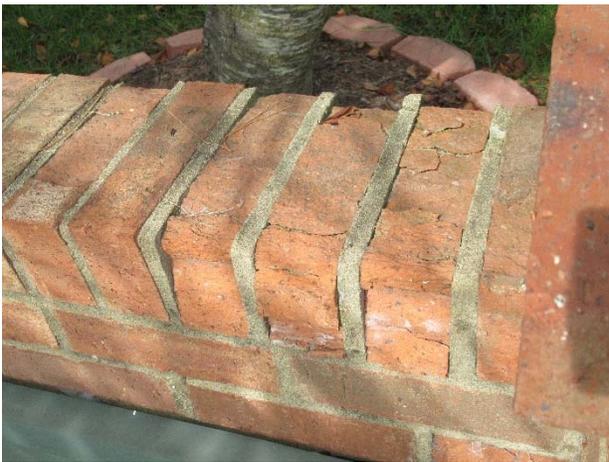
Masonry damage – Note: Bellerose Drive and Lees Corner Road

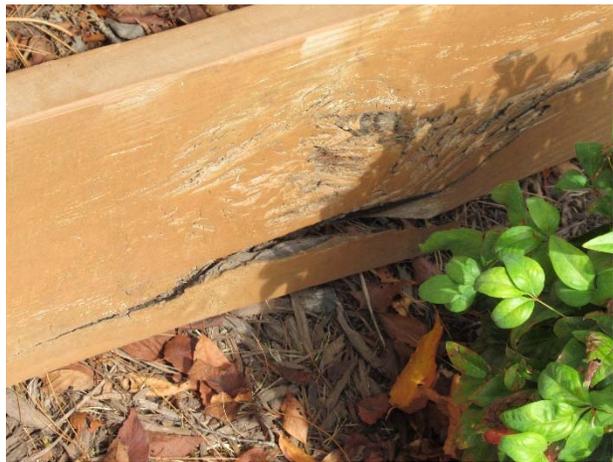
Wood damage – Note: Bellerose Drive and Lees Corner Road

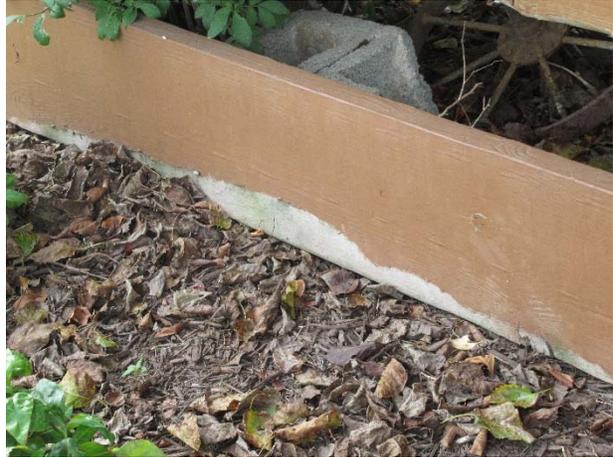
Finish deterioration – Note: Bellerose Drive and Lees Corner Road

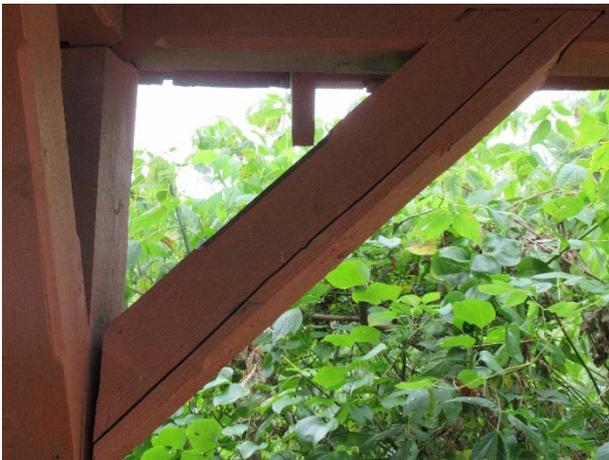
Wood split – Note: Bokel Drive and Lees Corner Road

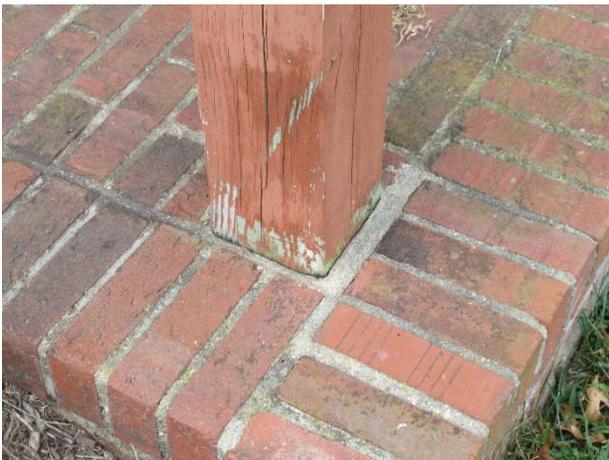
Wood split and finish deterioration – Note: Bokel Drive and Lees Corner Road

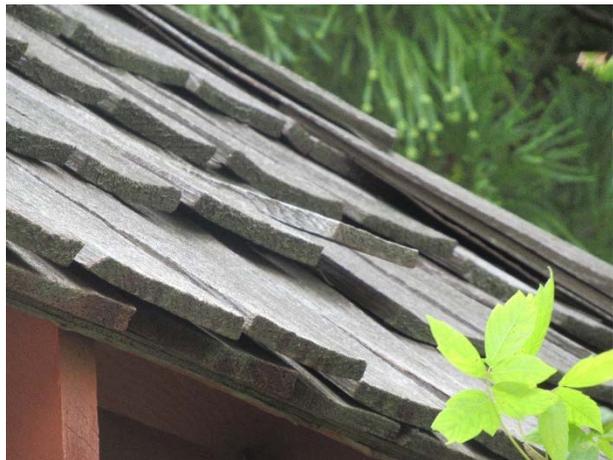
Shingle lift– Note: Bokel Drive and Lees Corner Road

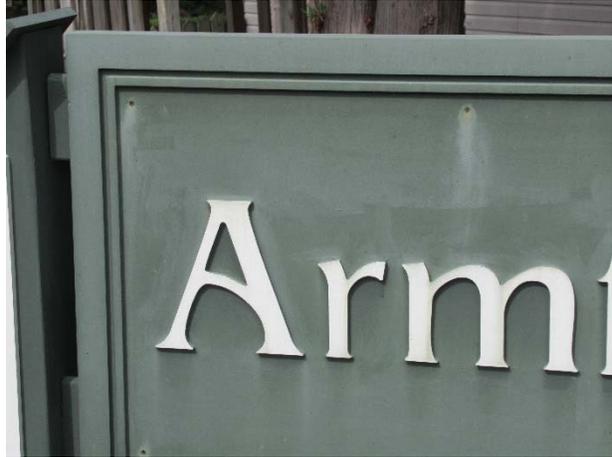
Finish deterioration – *Note: Bokel Drive and Lees Corner Road*

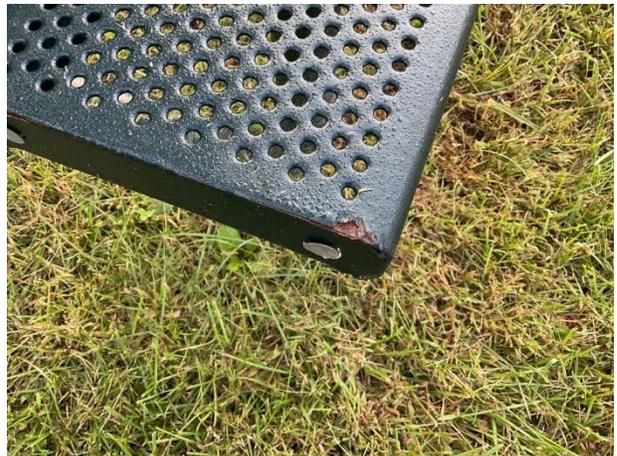
Finish deterioration and rust – Note: picnic table

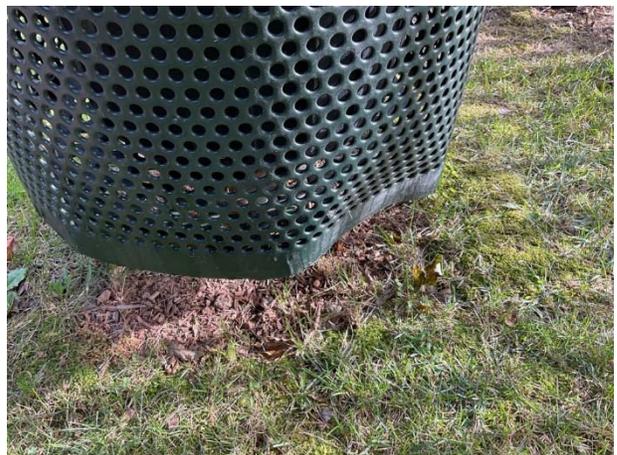
Damage

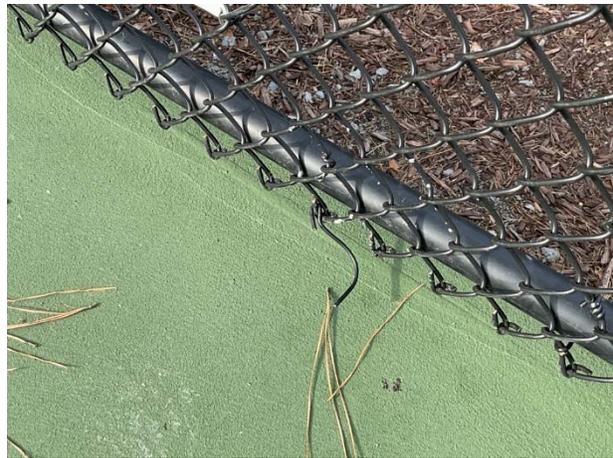
Loose link

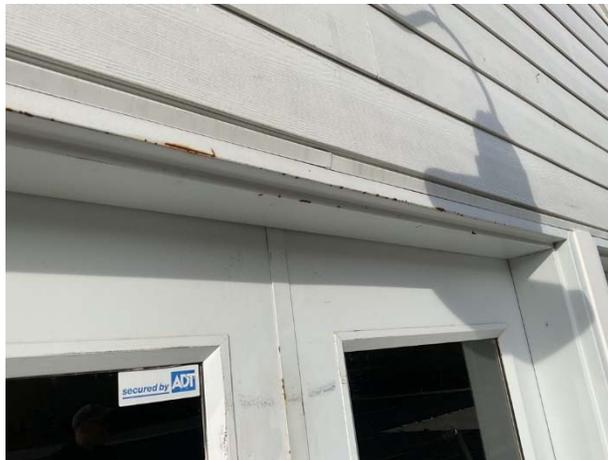
Entrance door rust – Note: rear entrance door

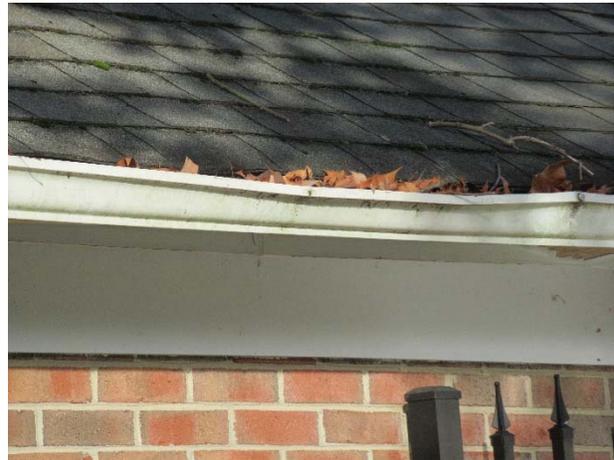
Condition: Good to fair overall with damaged gutters evident.

Damaged gutters

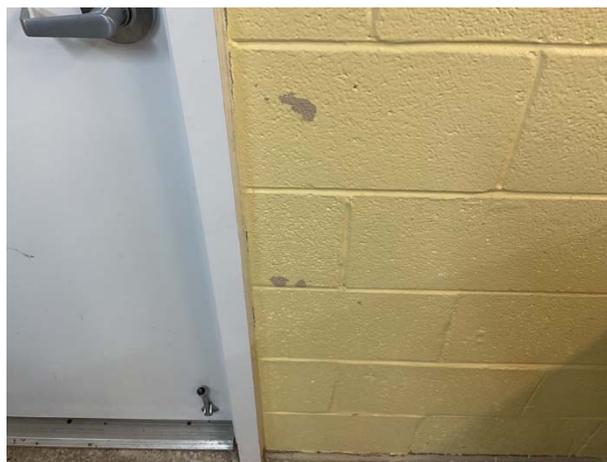
Condition: Good to fair overall with paint deterioration evident.

Paint deterioration

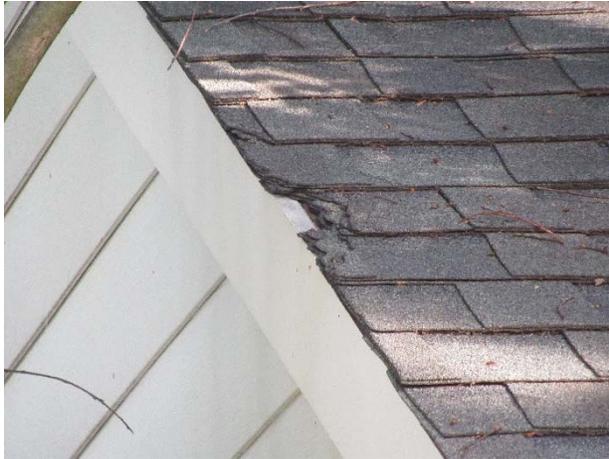
Condition: Good to fair overall with damaged shingles, curled shingles and staining evident. Management and the Board do not report a history of leaks.

Damaged shingle

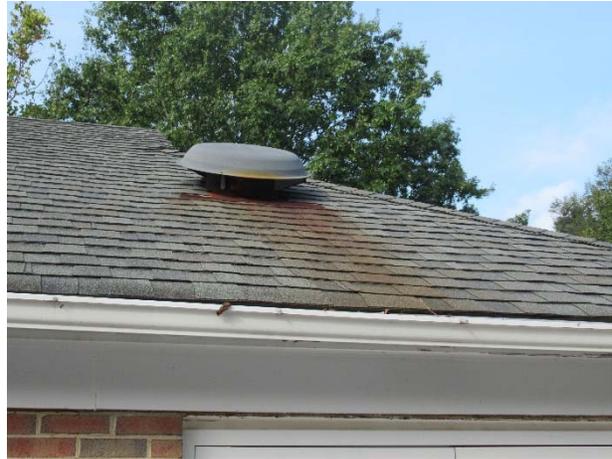
Curled and stained shingles

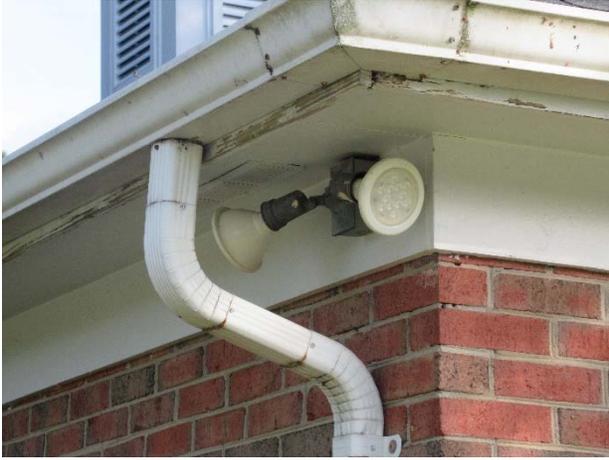
Condition: The siding was in good overall condition. The trim was in fair to poor overall condition with deterioration evident.

Trim deterioration

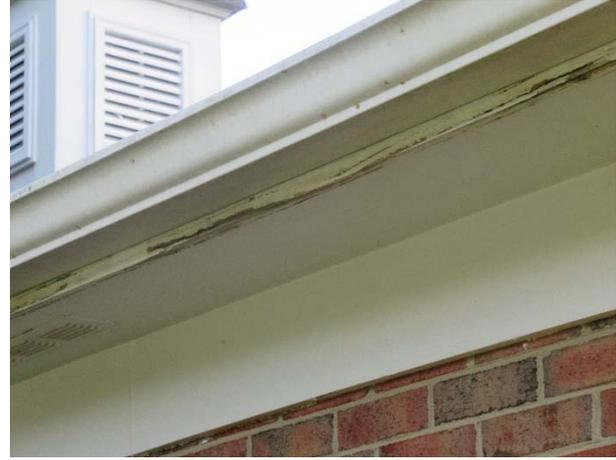
Trim deterioration

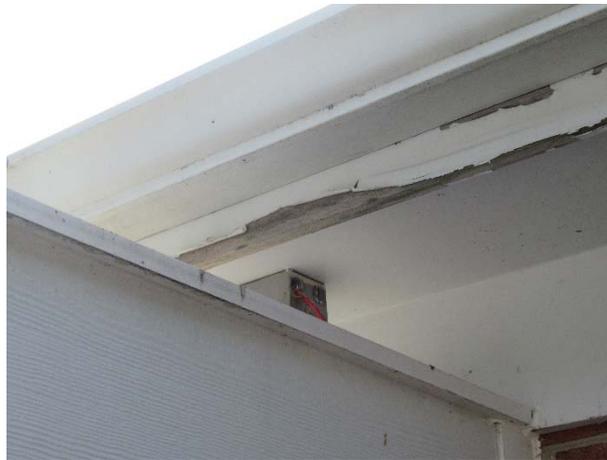
Trim deterioration

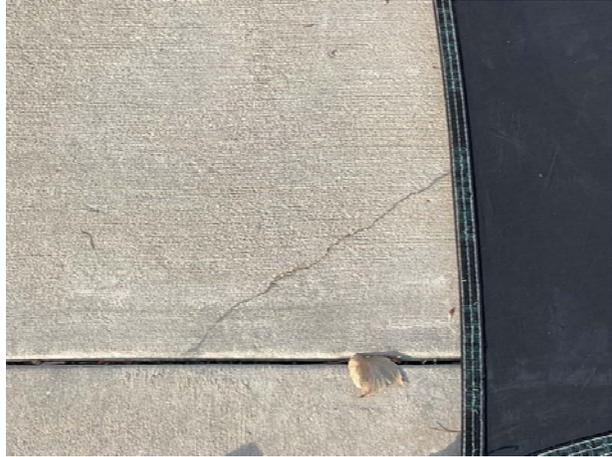
Concrete crack

Useful Life: The useful life of a concrete pool deck is up to 60 years or more with timely repairs. We recommend the Association conduct inspections, partial replacements and repairs to the deck every 8- to 12-years.

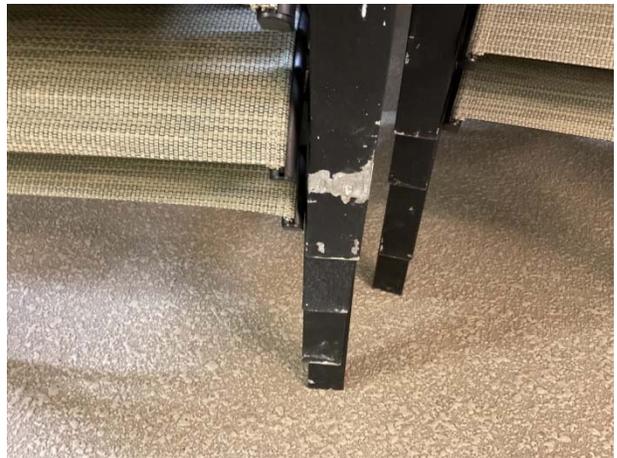
Finish deterioration

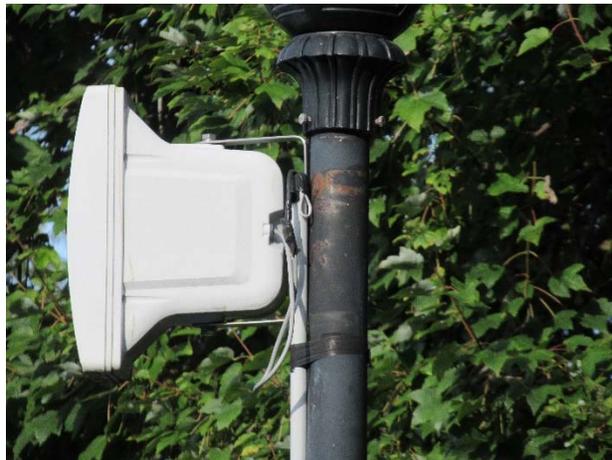
Finish deterioration and rust

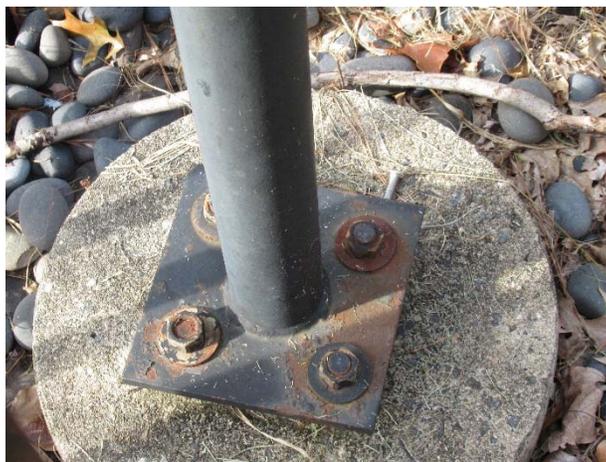
Finish deterioration and rust

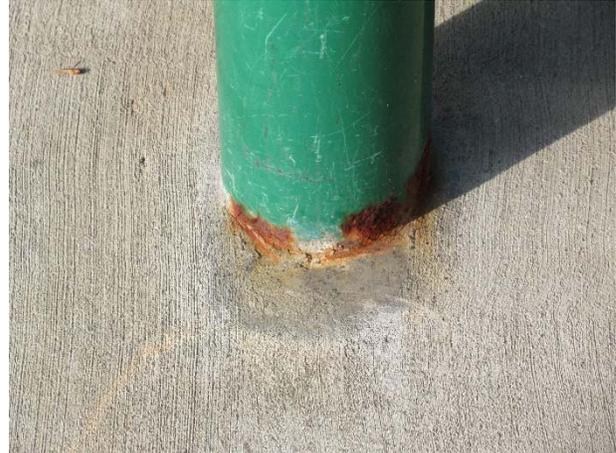
Finish deterioration and rust – Note: wading pool

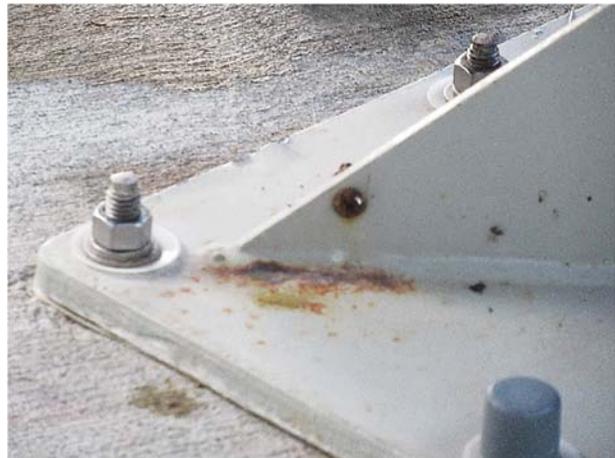
Conditions: Good to fair overall with base rust evident.

Base rust
