Revised
FULL RESERVE STUDY
Armfield Farm
Homeowners Association

Chantilly, Virginia

Inspected - September 13, 2018

Revised - January 18, 2019

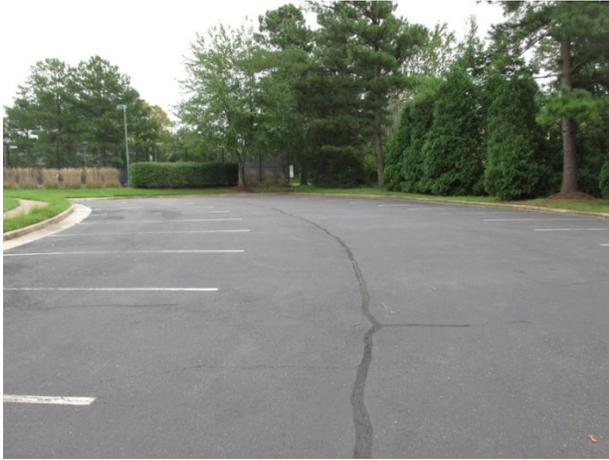
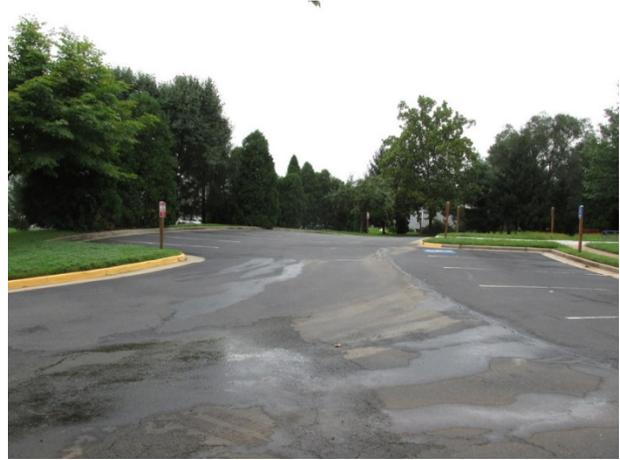
Condition: Good to fair overall with cracks and previous repairs evident

Parking area overview

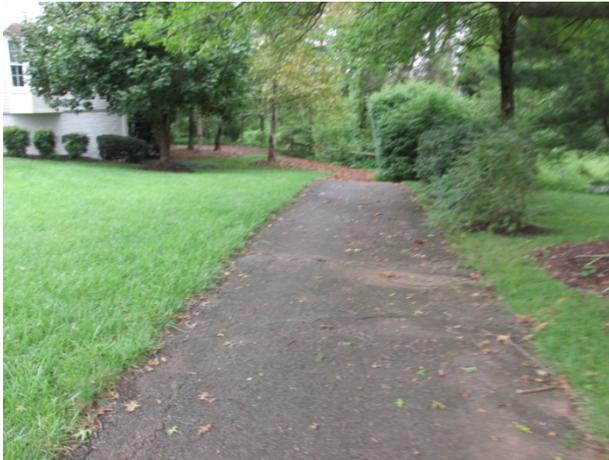
Condition: The paths at Clary Sage Road are in poor condition with extensive cracking and heave evident. The remaining paths are in good to fair overall condition with minor cracking evident.

Clary Sage path overview

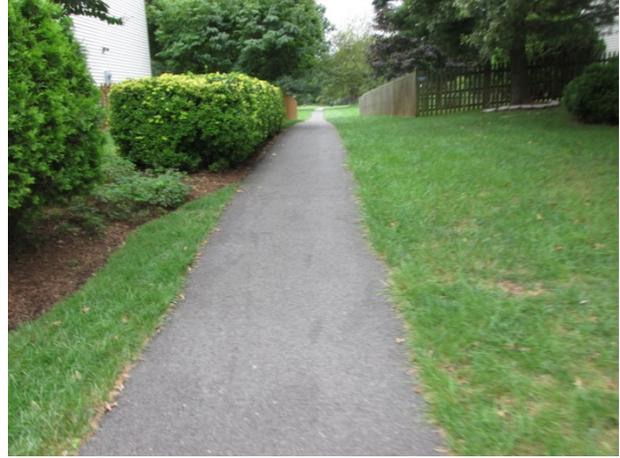
Newer walking path

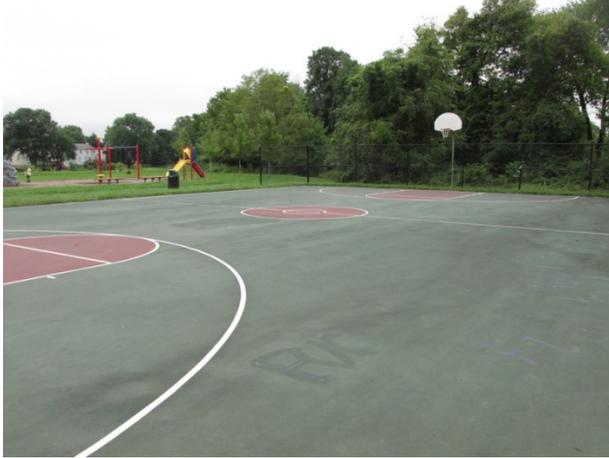
Condition: Fair overall with surface stains

Basketball court at Springhaven Drive

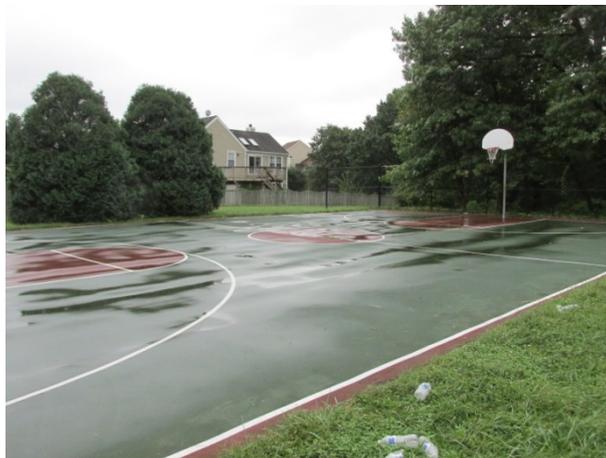
Basketball court at Beach Down Drive

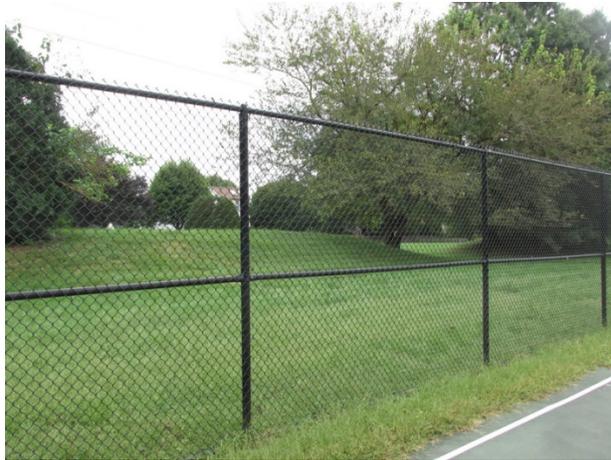
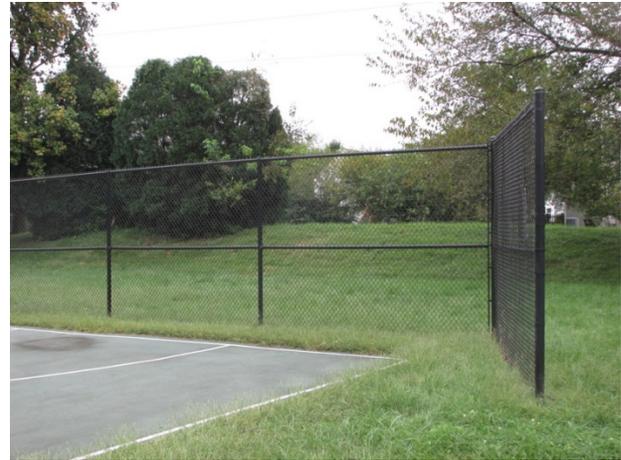
Condition: Good overall

Chain link fence

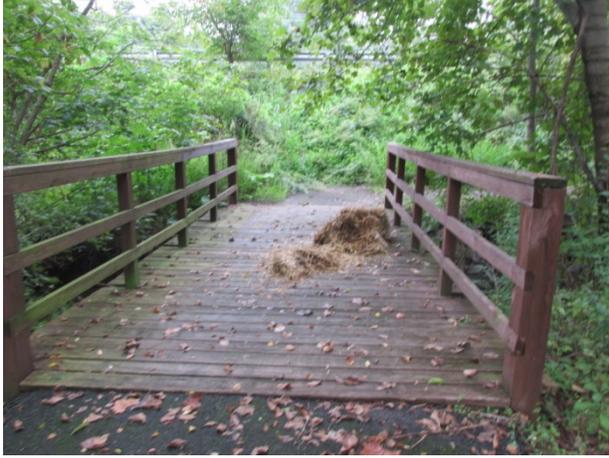
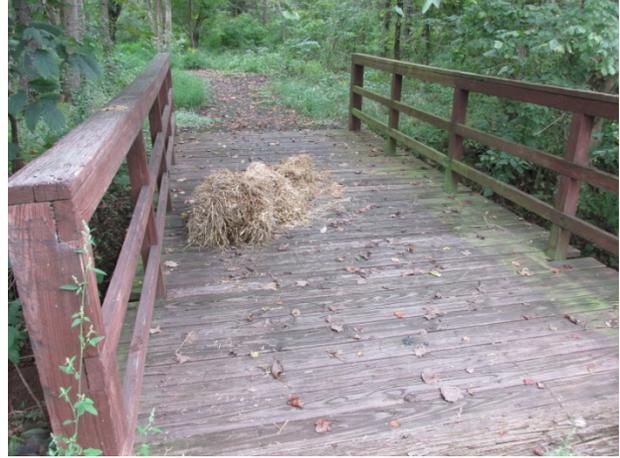
Condition: Fair overall condition with nail pop and wood deterioration evident

Wood bridge

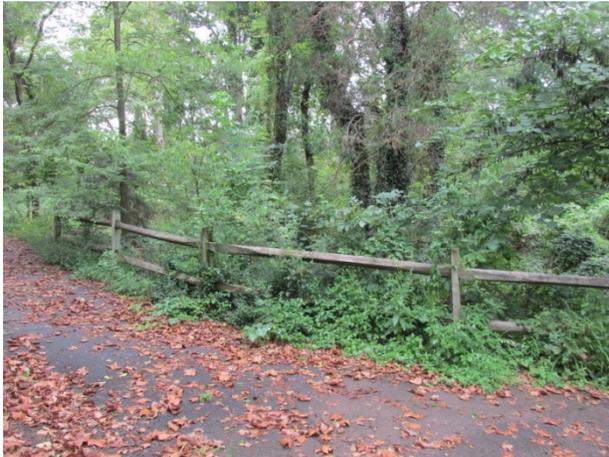
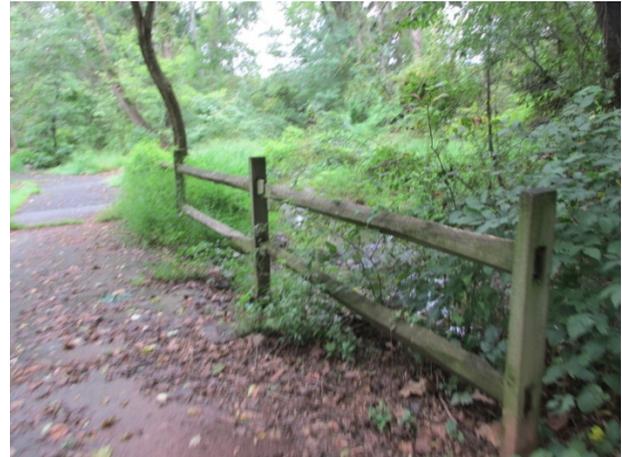
Condition: Fair to poor overall with extensive erosion noted at the concrete footers. Management informs us the Association plans to re-set the fences further from the creek at the time of replacement.

Split rail fence

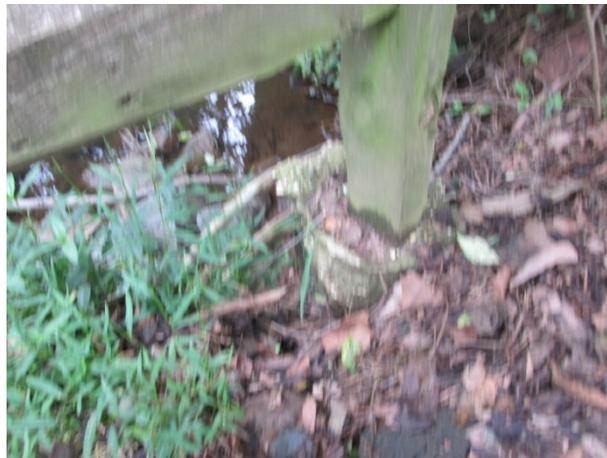
Erosion at concrete footer

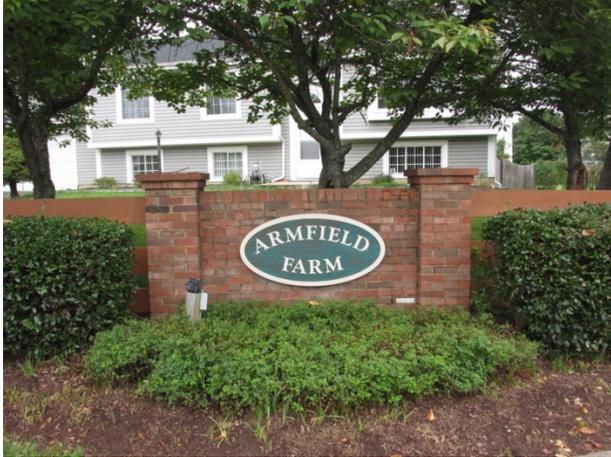
Bellerose Drive signage

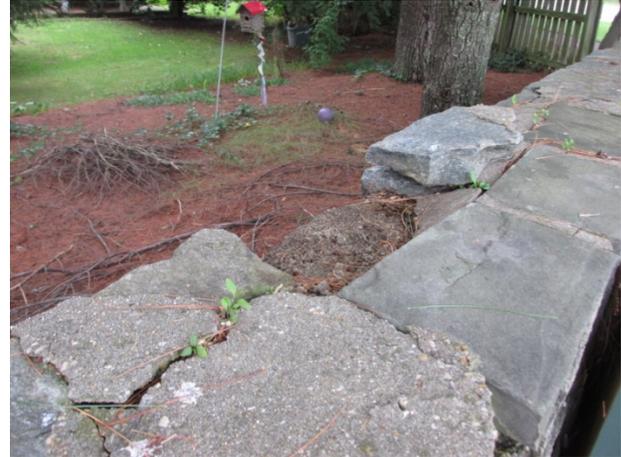
Masonry displacement

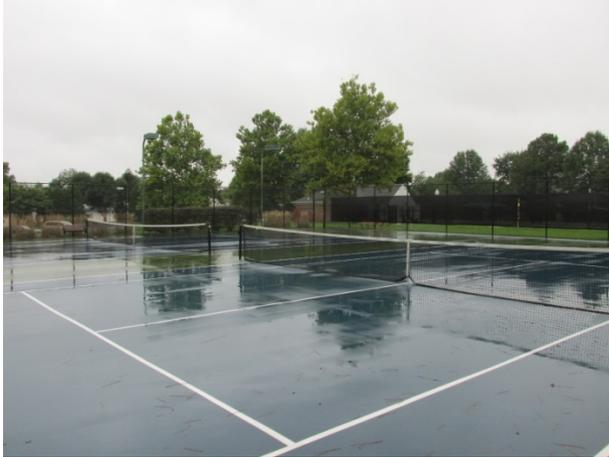
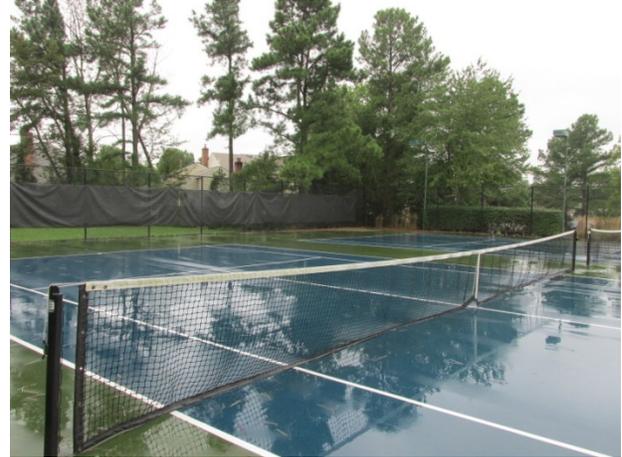
Condition: Good to fair overall with minor stains evident

Tennis courts

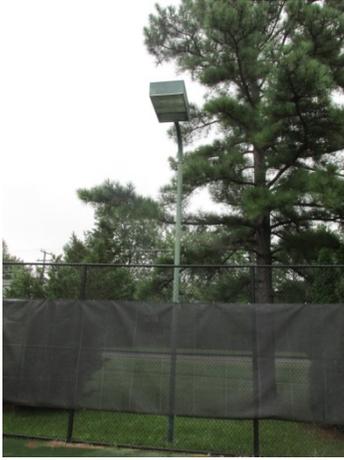
Condition: Fair overall with rust and finish deterioration evident

Light pole and fixture

History: Original. Management informs us the Association plans to replace the fixtures with LED (light-emitting diode) fixtures at the time of replacement.

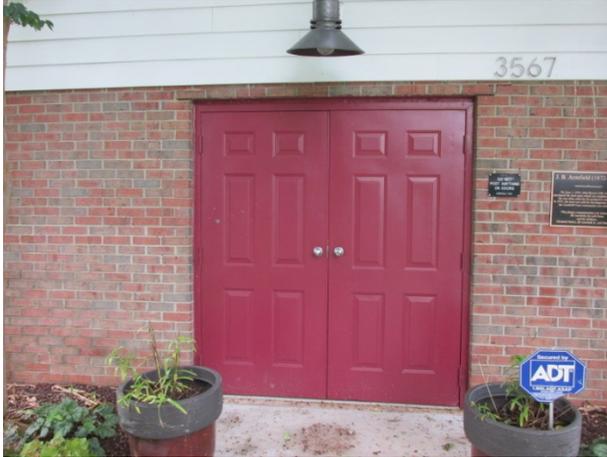
Condition: Fair overall condition with rust evident. Management informs us the Association plans to replace the doors in the near term.

Entrance doors

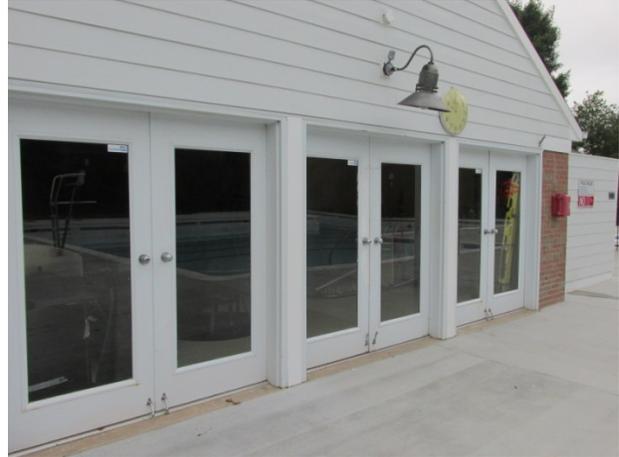
Doors at pool house rear

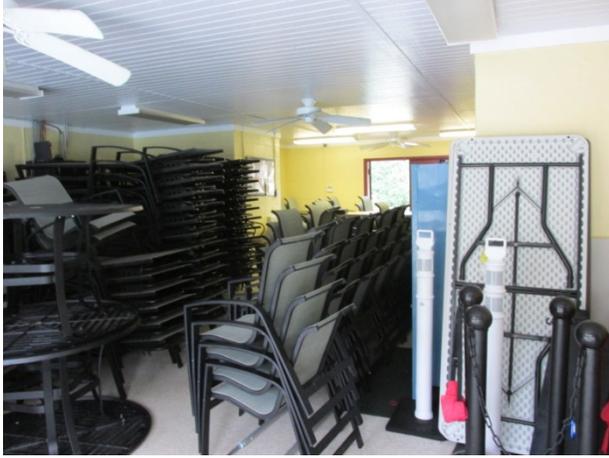
Condition: Good overall

Entryway overview

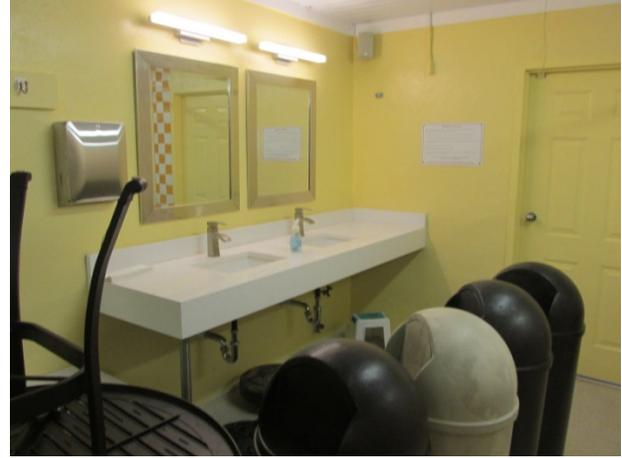
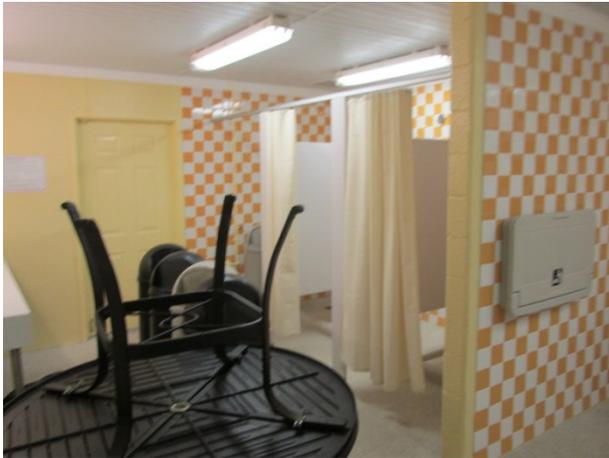
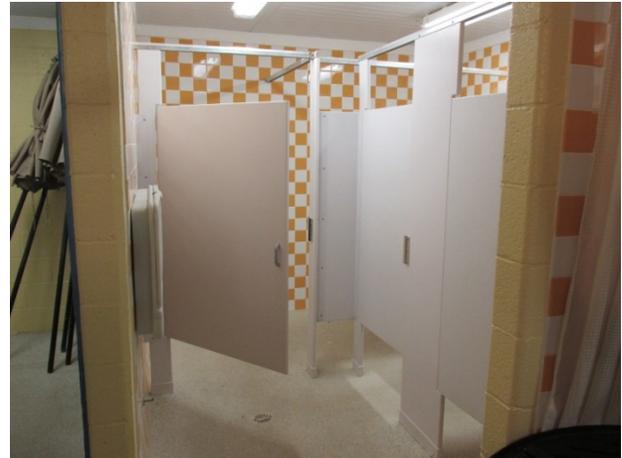
Rest room overview

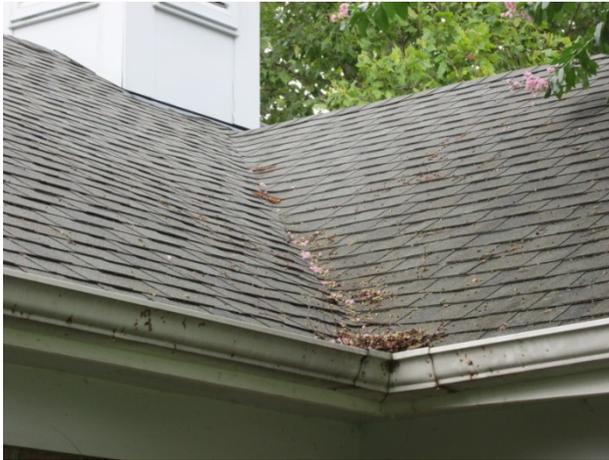
Condition: Good overall condition. Management does not report a history of leaks.

Asphalt shingle roof

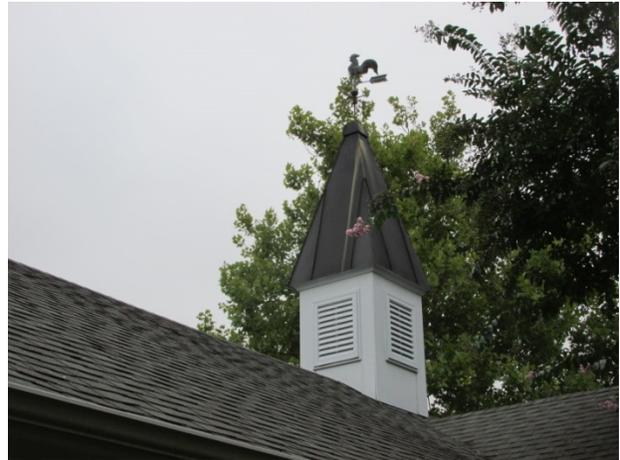
Cupola

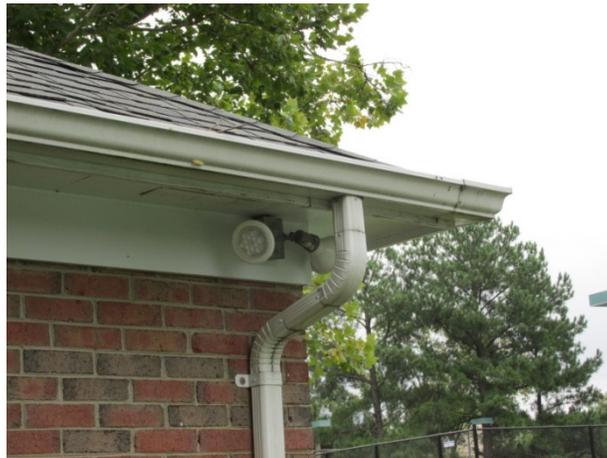
Aluminum gutter and downspout assembly

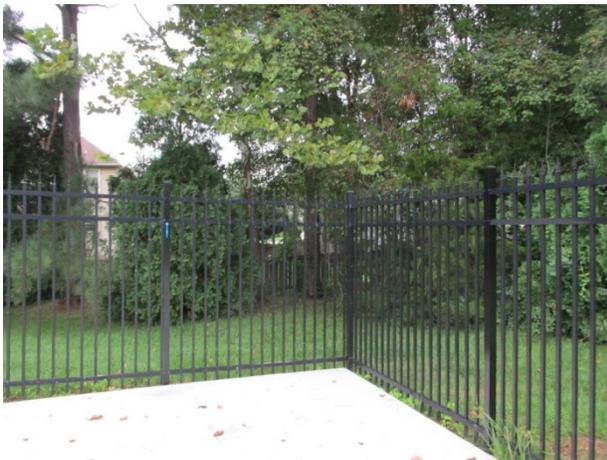
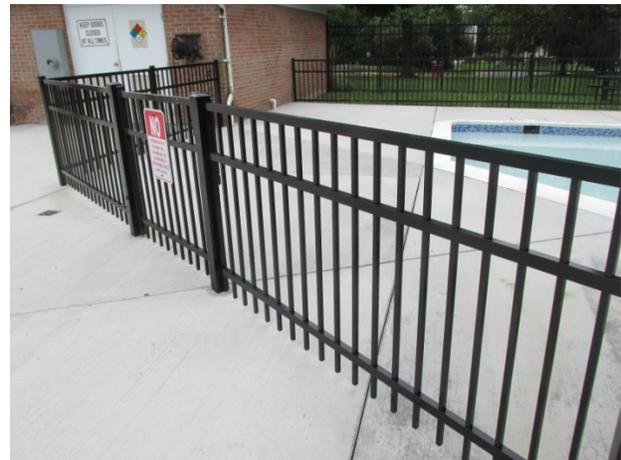
Condition: Good overall

Pool fence

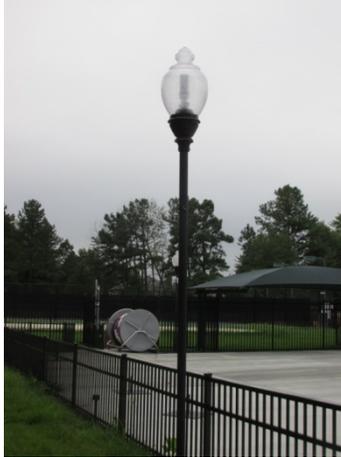
Condition: Good to fair overall with isolated finish deterioration evident

Light pole and fixture

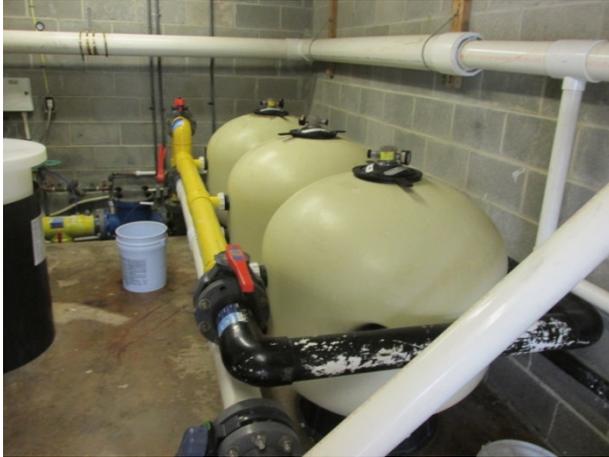
Condition: Reported satisfactory

Pool mechanical equipment

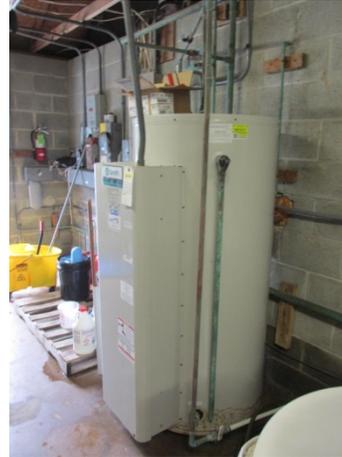
Water heater

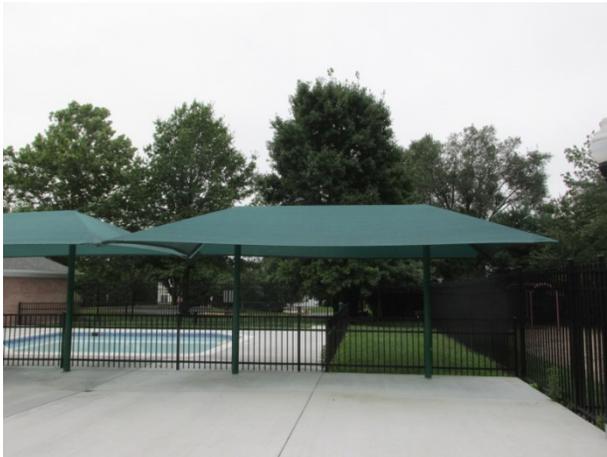
Condition: Good overall

Shade structures at wading pool

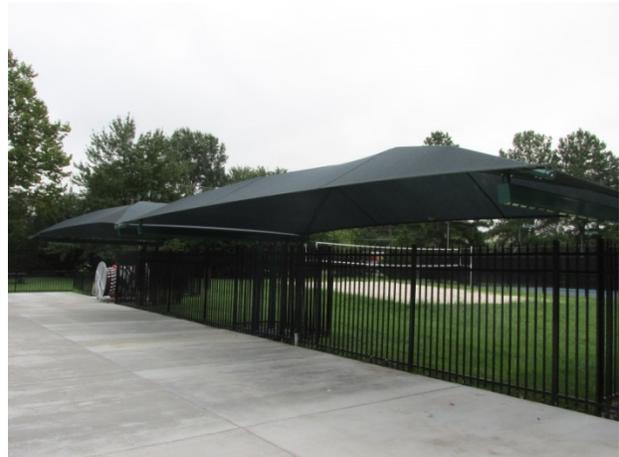
Shade structures adjacent to main pool

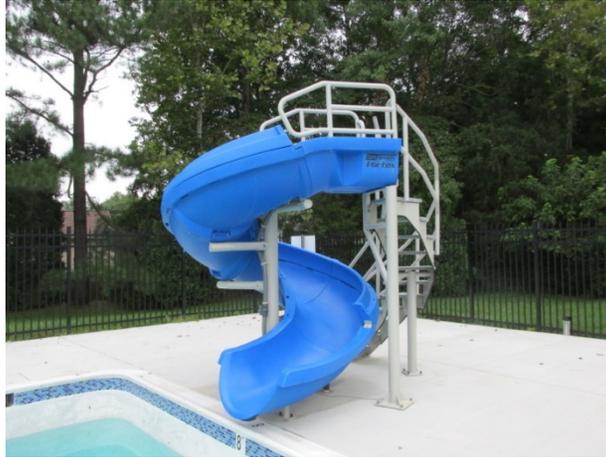
Conditions: Good overall

Water slide

Component Detail Notes: Safety is the major purpose for maintaining the water slide. We recommend an annual inspection of the water slide to identify and repair as normal maintenance loose connections and fasteners or damaged elements. We recommend the use of a specialist for the design or replacement of the water slide environment.
