Armfield Farm

Homeowners Association

September 20, 2023 • Chantilly, VA

RESERVE STUDY

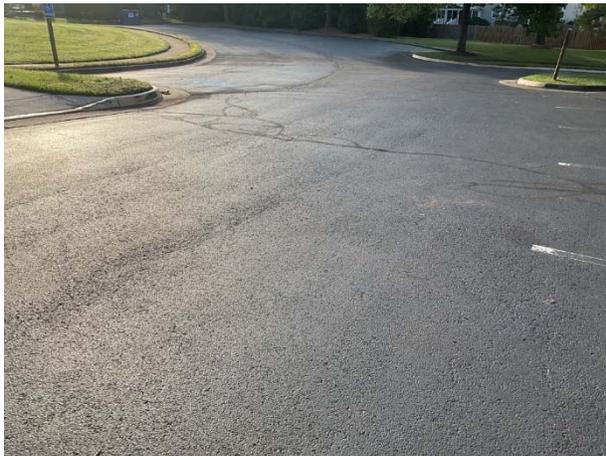
Condition: Fair overall with cracks, repairs, root intrusion, concrete damage and collar damage evident.

Pavement overview

Component Detail Notes: Proposals should include mechanically routing and filling all cracks with hot emulsion. Repairs should also include patching at areas exhibiting settlement, potholes, or excessive cracking. The contractor should only apply seal coat applications after repairs are completed. A seal coat does not bridge or close cracks, therefore, unrepaired cracks render the seal coat applications useless. These activities minimize the damaging effects of vehicle fluids, maintain a uniform and positive appearance, and maximize the useful life of the pavement.

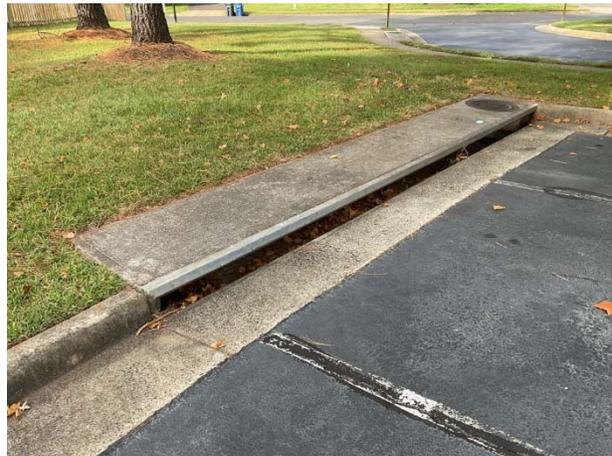
Catch basin

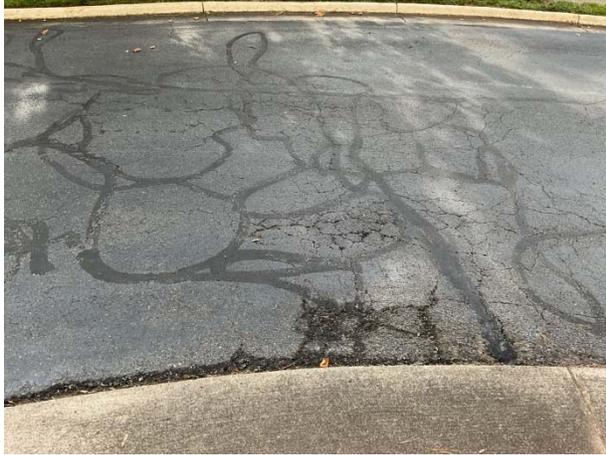
Asphalt cracks and repairs

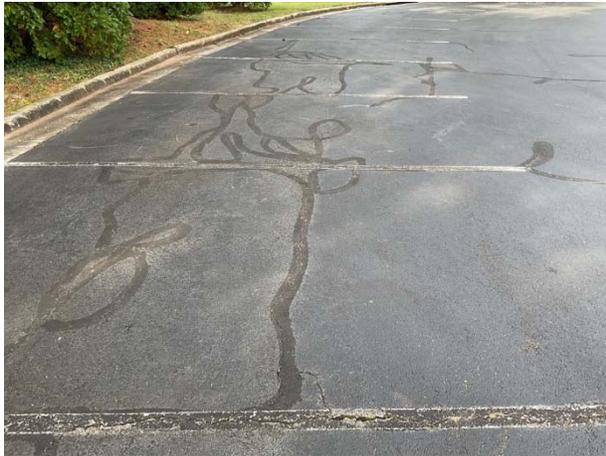
Crack repairs

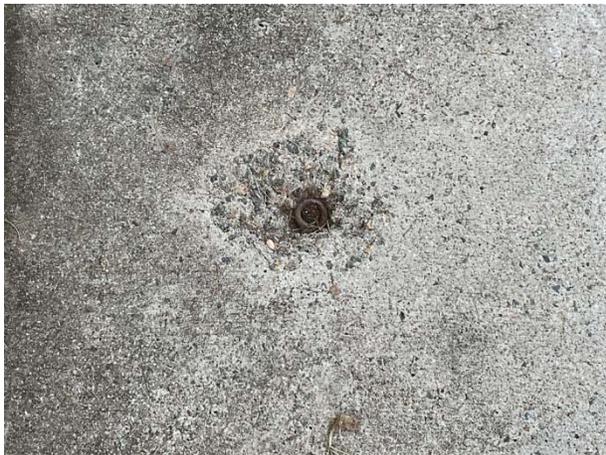
Concrete damage – Note: catch basin

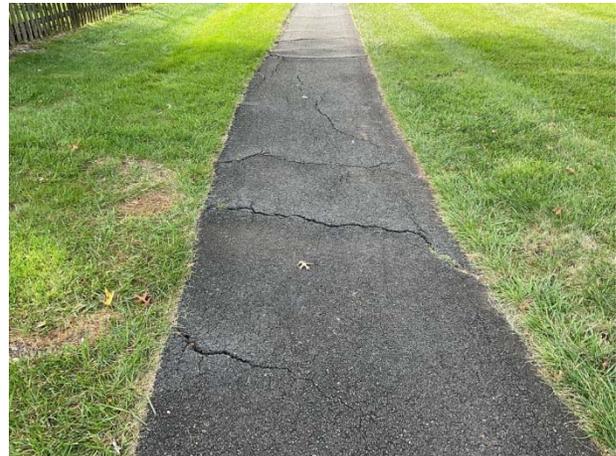
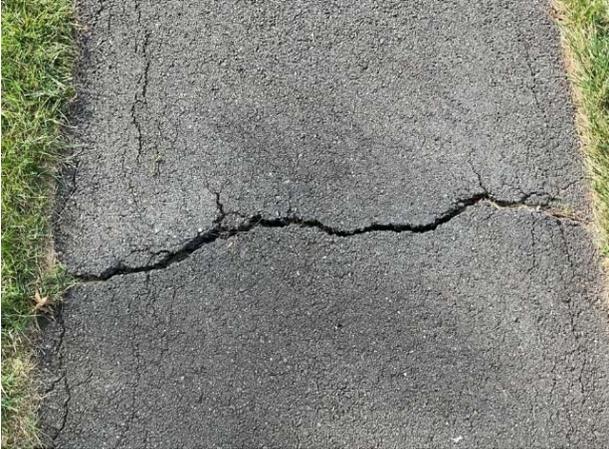
Asphalt cracks – Note: between Kew Garden Court and Beech Down Drive

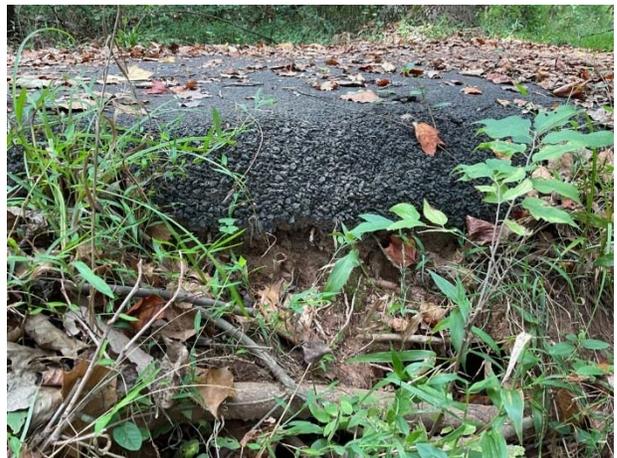
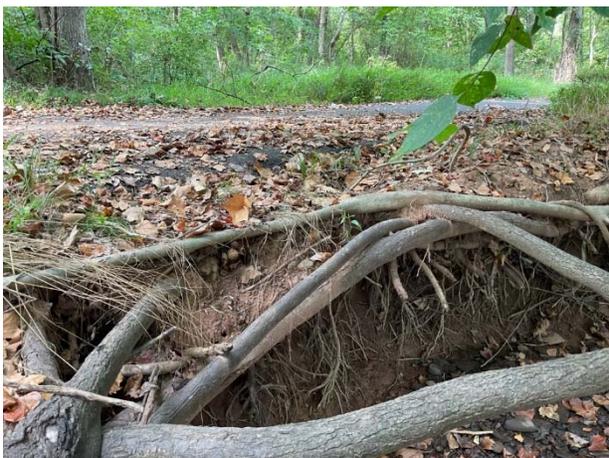
Undermining – Note: Clary Sage Drive

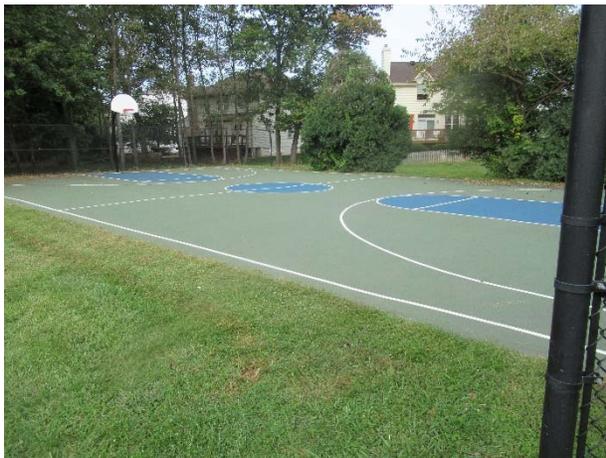
Condition: The court at Beach Down Drive is in good to fair overall condition with isolated damage and cracks evident. The surface at Springhaven Drive is in fair to poor overall condition with cracks and surface deterioration evident.

Basketball court overview – Note: Beach Down Drive

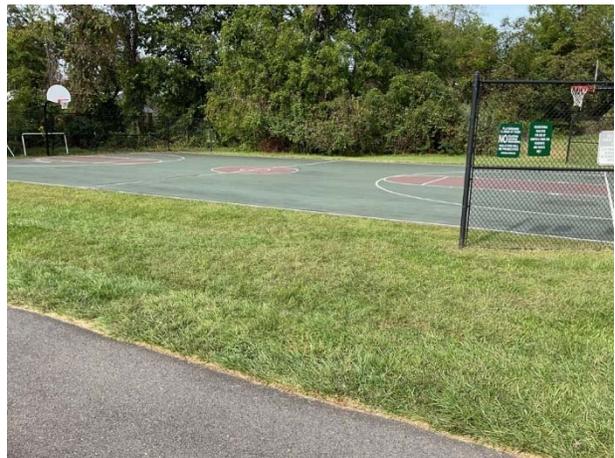
Basketball court overview – Note: Springhaven Drive

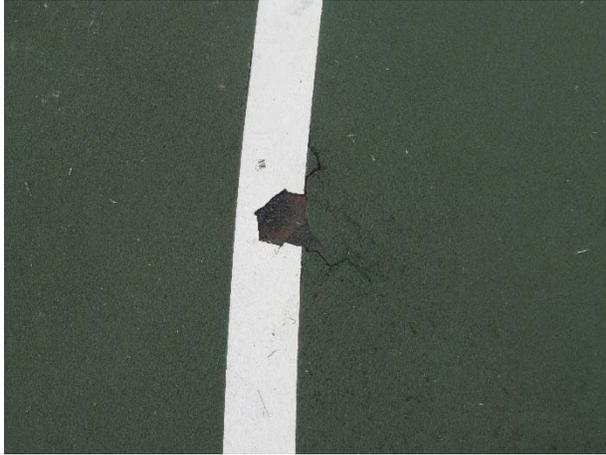
Surface damage – Note: *Beach Down Drive*

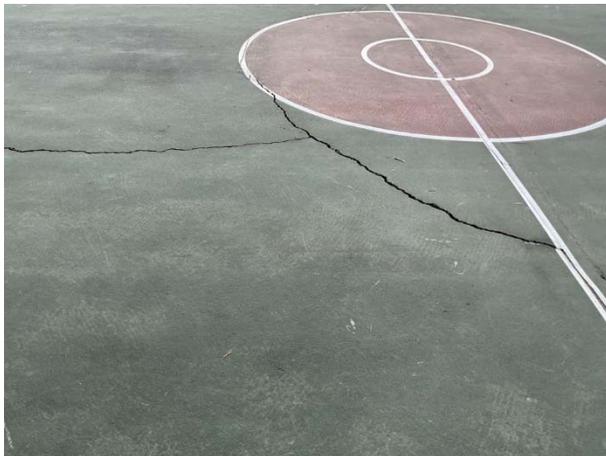
Pavement cracks – Note: *Springhaven Drive*

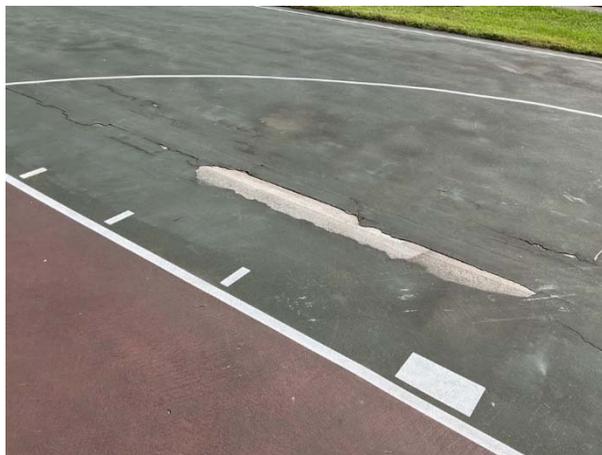
Surface deterioration and cracks

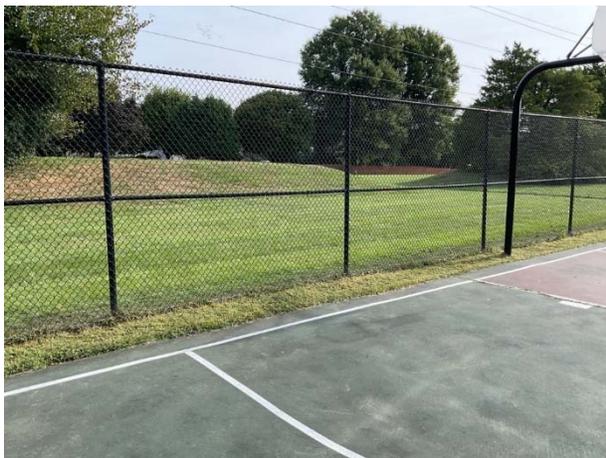
Condition: Good to fair overall with rust, displaced post and overgrowth evident.

Fence overview

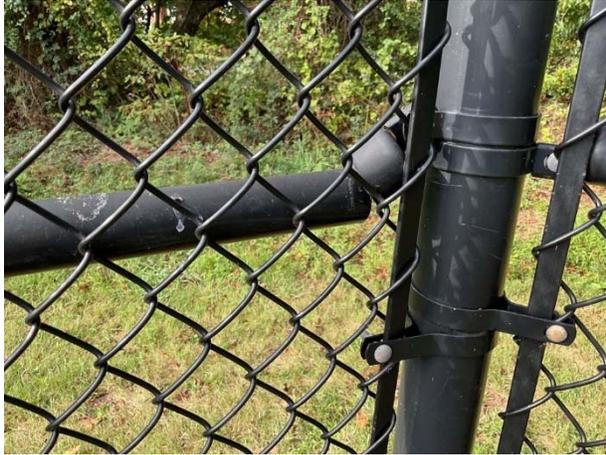
Displaced post

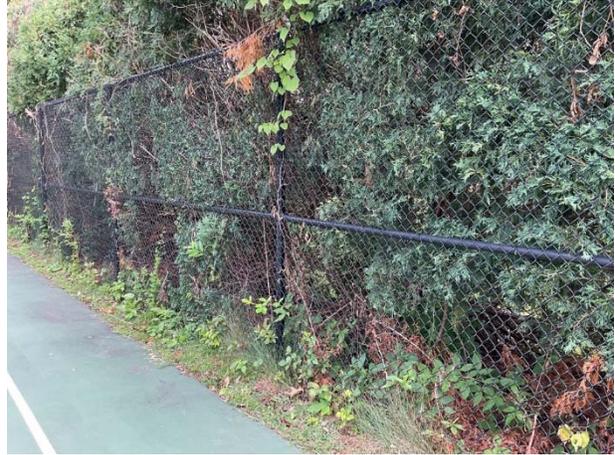
Overgrowth

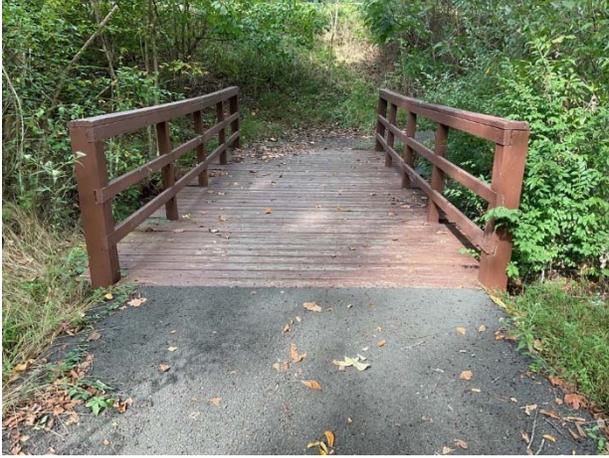
Condition: Fair overall with wood split, damage, deterioration, loose boards and erosion evident. We recommend conducting further inspections in the near term to ensure erosion is not causing structural instability at the bridge.

Wood bridge

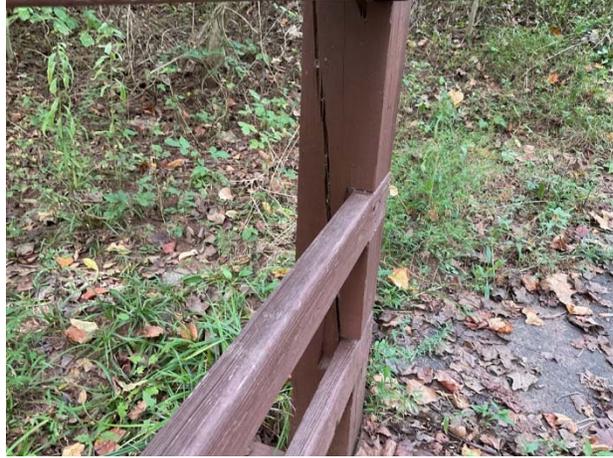
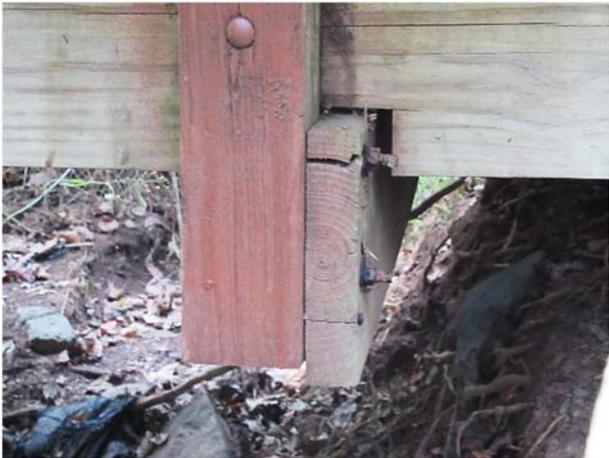
Wood split

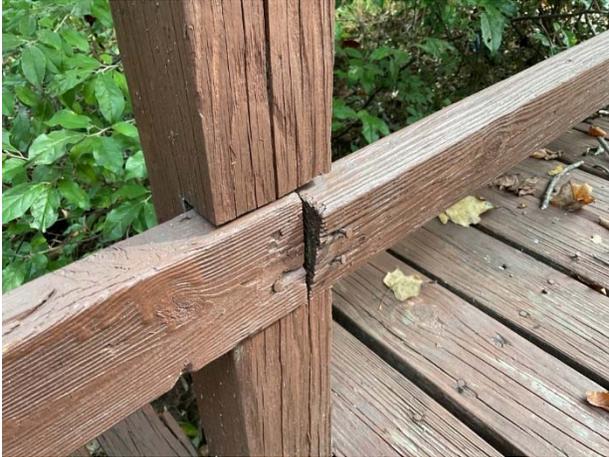
Loose board

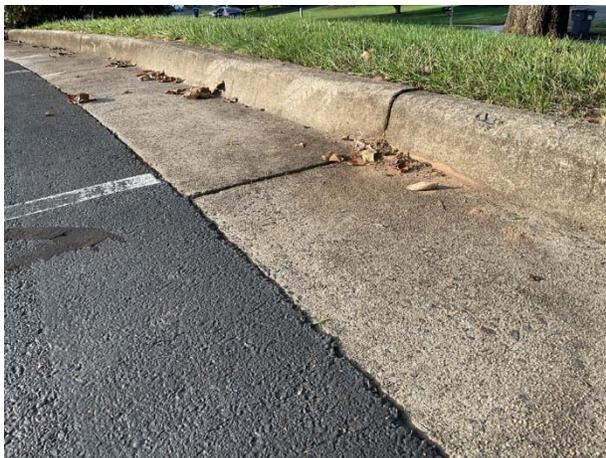
Condition: Good to fair overall with cracks, heave and settlement evident.

Curb and gutter overview

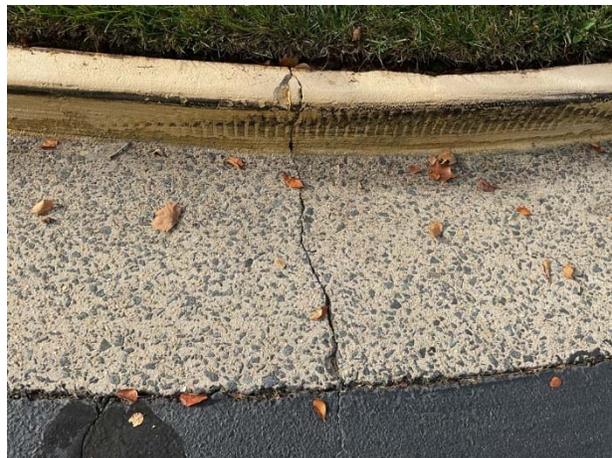
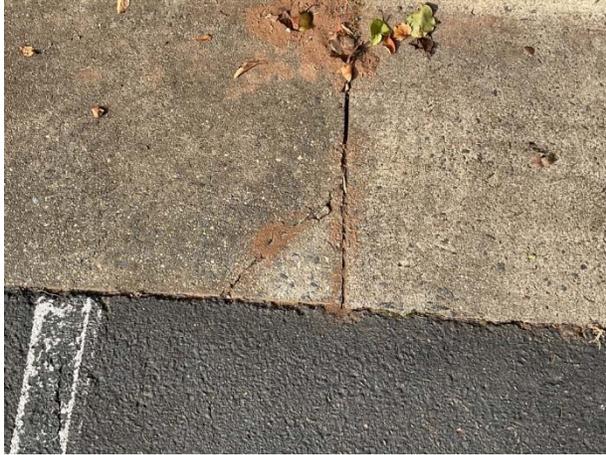
Concrete crack

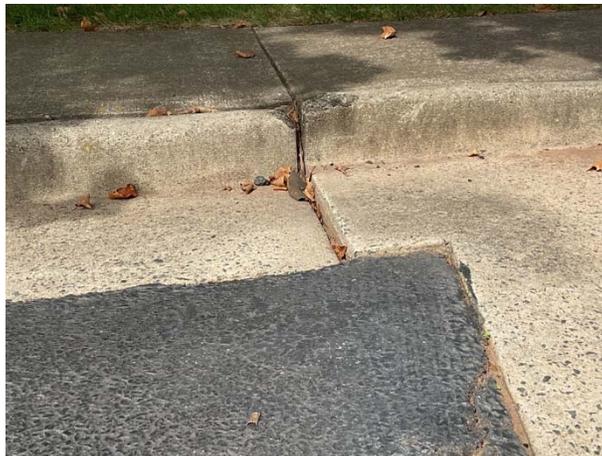
Settlement

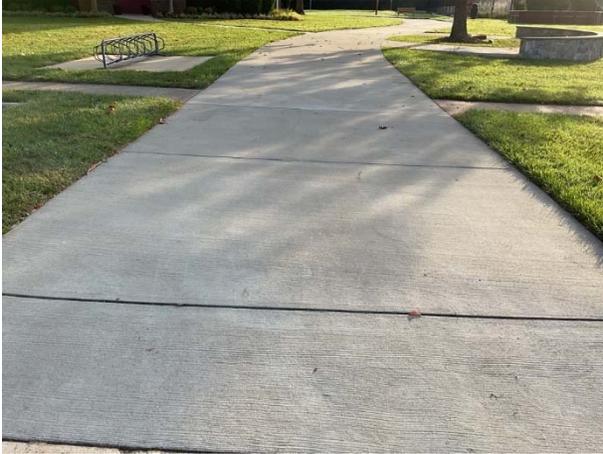
Condition: Good to fair overall with cracks evident.

Concrete sidewalk

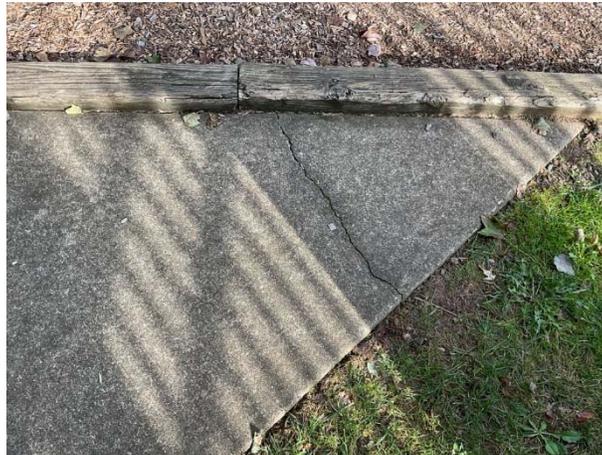
Concrete crack

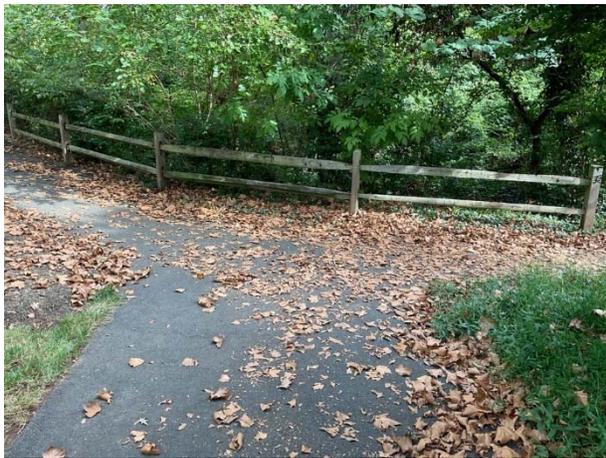
Condition: Good to fair overall with leaning sections evident.

Fence overview

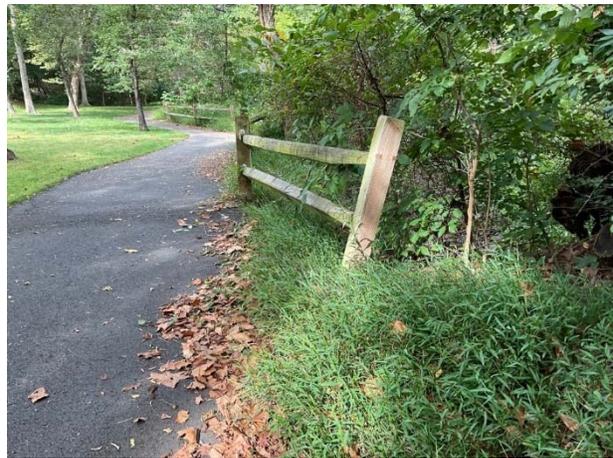
Leaning section

- Annually:
 - Inspect and repair loose sections, and damage
 - Repair leaning sections and clear vegetation from fence areas which could cause damage

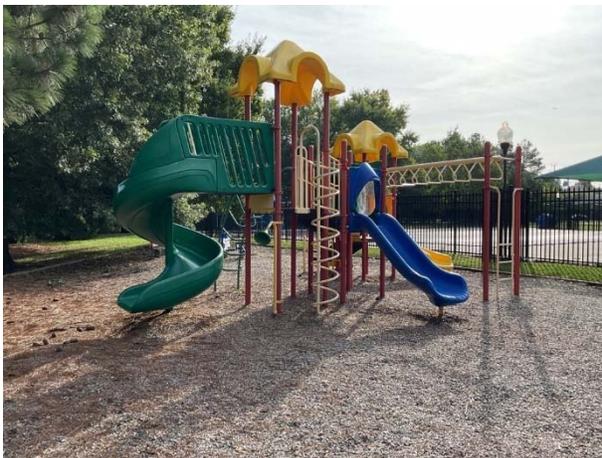
Location	Year of Replacement	Condition
Pool House	1999	Fair to poor overall with extensive finish deterioration and rust evident
Clary Sage Drive	2003	Fair to poor overall with finish deterioration, rust, stains, dented equipment, faded equipment wood deterioration, exposed border fasteners and mulch depletion evident
Springhaven Drive, North	2012	Fair overall with finish deterioration and rust evident
Springhaven Drive, South	2012	Good to fair overall with finish deterioration and rust evident

Playground equipment – *Note: pool house*

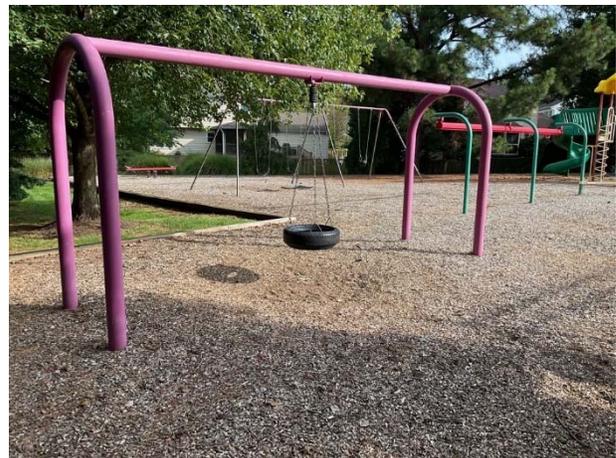
Playground equipment – *Note: pool house*

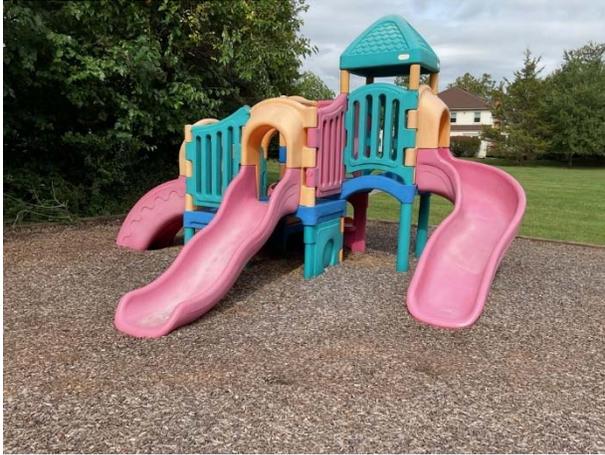
Playground equipment – Note: *Clary Sage Drive*

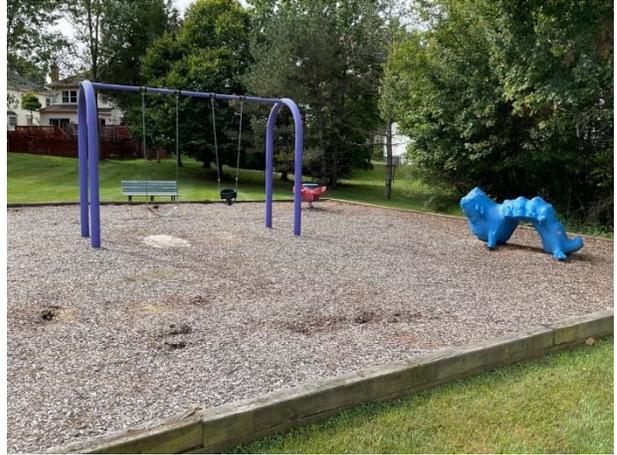
Playground equipment – Note: *Clary Sage Drive*

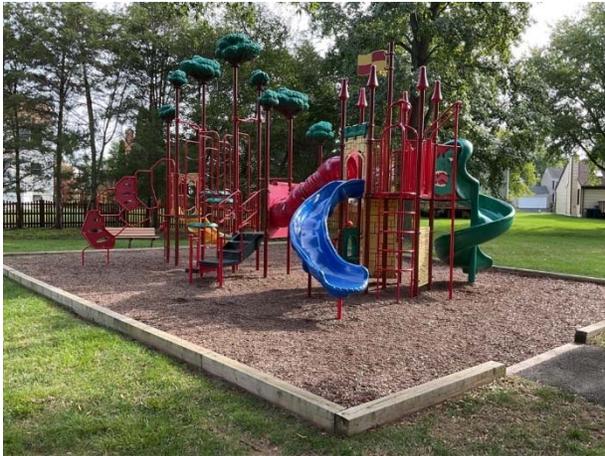
Playground equipment – Note: *Springhaven Drive, North*

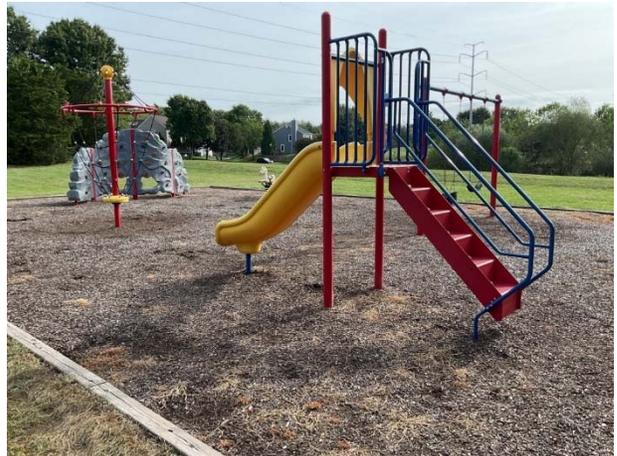
Playground equipment – Note: *Springhaven Drive, South*

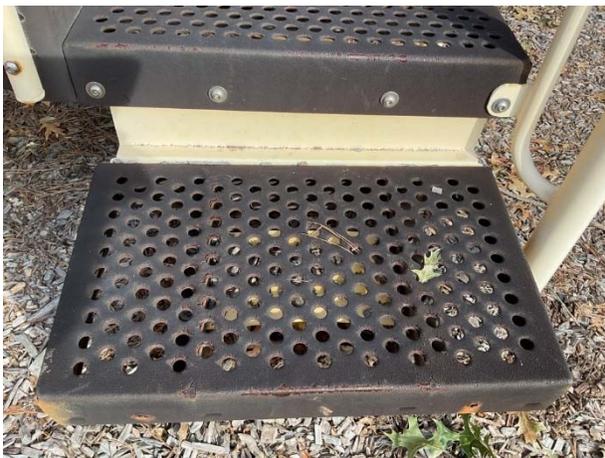
Finish deterioration and rust – Note: *pool house*

- Annually:
 - Inspect and repair loose connections and fasteners or damaged elements
 - Inspect for safety hazards and adequate coverage of ground surface cover

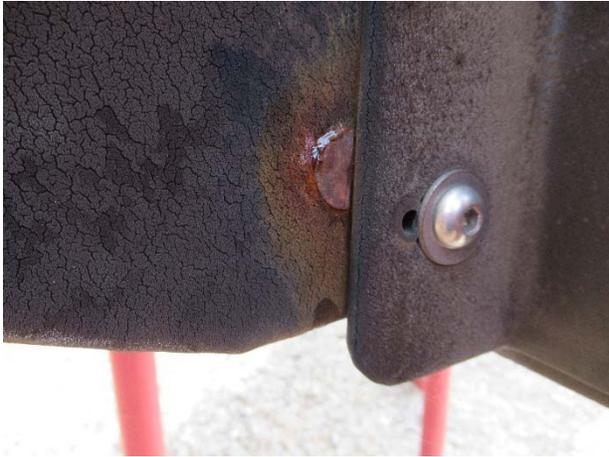
Finish deterioration and fastener rust – Note: pool house

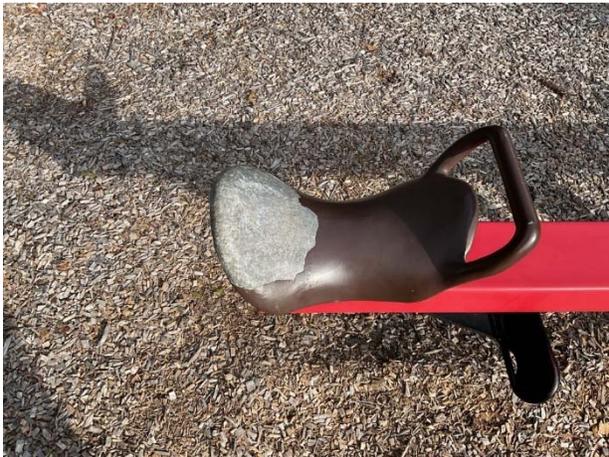
Finish deterioration – Note: pool house

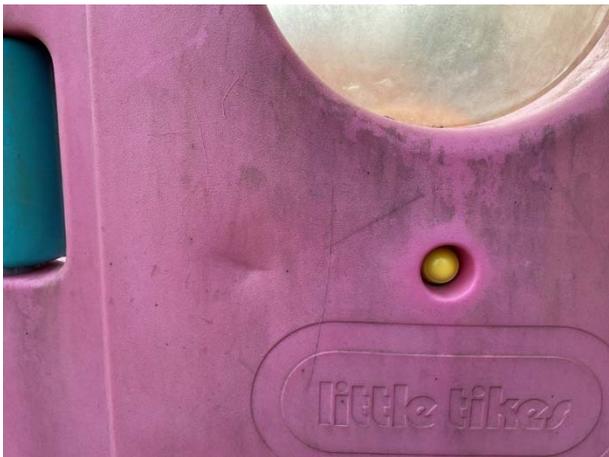
Stains and dented equipment – Note: Clary Sage Drive

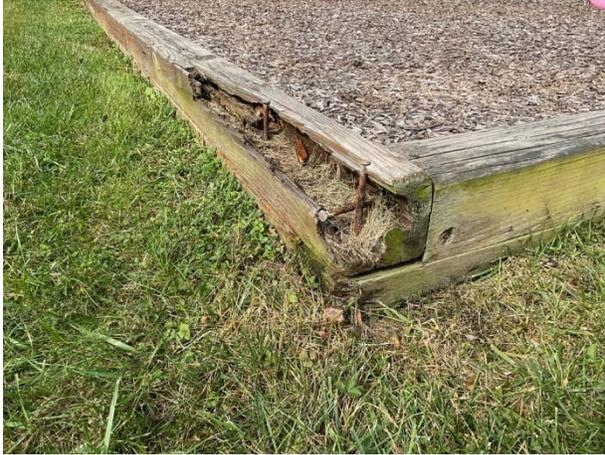
Wood deterioration and exposed border fasteners
– *Note: Clary Sage Drive*

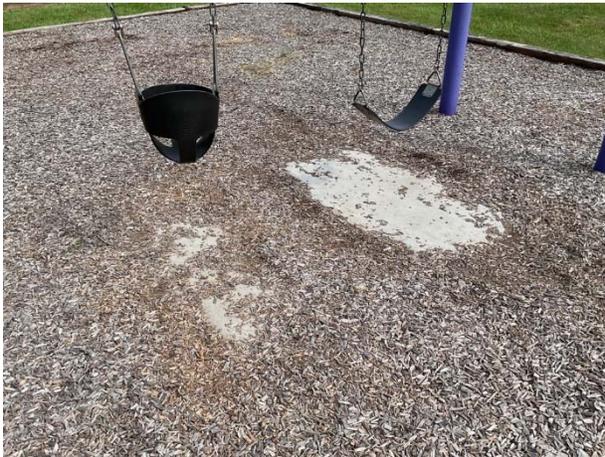
Mulch depletion – *Note: Clary Sage Drive*

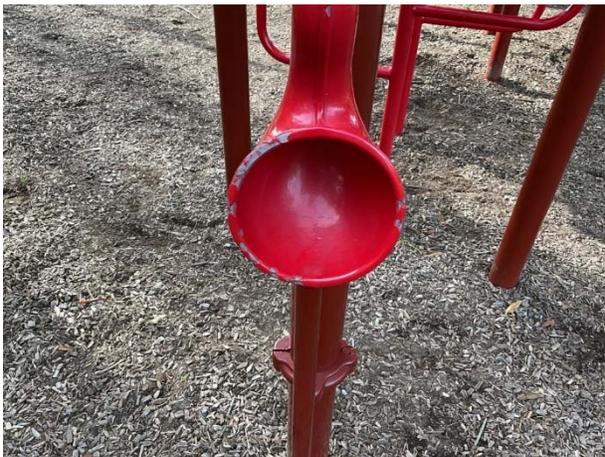
Finish deterioration – *Note: Springhaven Drive, North*

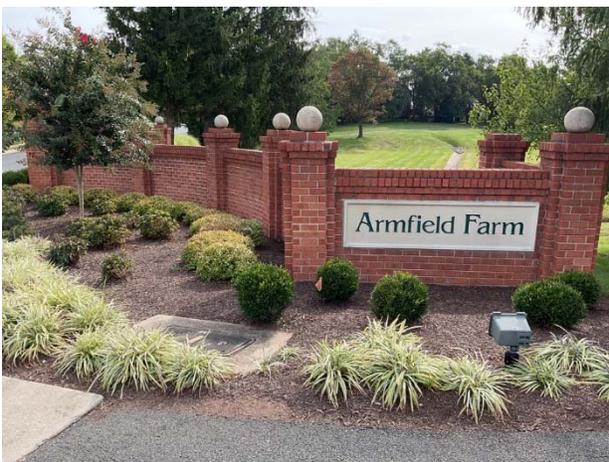
Location	Components	Condition
Centerville Road and Armfield Farm Drive	<ul style="list-style-type: none"> ·Landscaping ·Light fixtures ·Masonry, brick ·Signs, concrete 	Good to fair overall with mortar deterioration, masonry cracks and damage evident
Springhaven Drive and Lees Corner Road	<ul style="list-style-type: none"> ·Landscaping ·Light fixtures ·Masonry, stone ·Signs, composite 	Good to fair overall with mortar cracks evident
Bellerose Drive and Lees Corner Road	<ul style="list-style-type: none"> ·Fence, wood rail ·Landscaping ·Light fixtures ·Masonry, brick ·Signs, composite ·Solar Panel 	Fair overall with masonry damage, wood damage, wood split and finish deterioration evident
Bokel Drive and Lees Corner Road	<ul style="list-style-type: none"> ·Landscaping ·Fence, wood picket ·Light fixtures ·Masonry, brick ·Sign, composite ·Well structure 	Fair overall with wood split, finish deterioration and shingle lift evident

Entrance monument overview – Note:
Centerville Road and Armfield Farm Drive

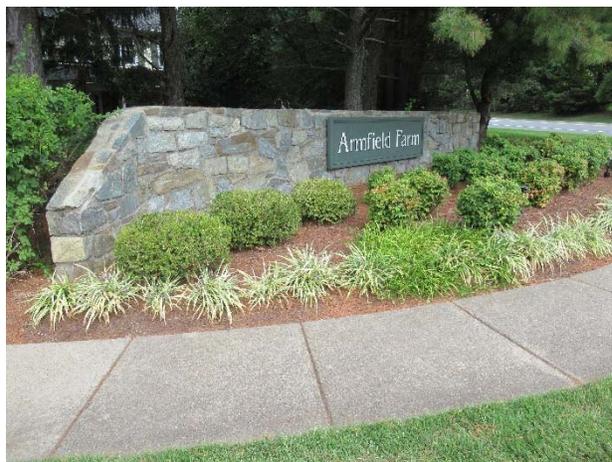
Entrance monument overview – Note:
Springhaven Drive and Lees Corner Road

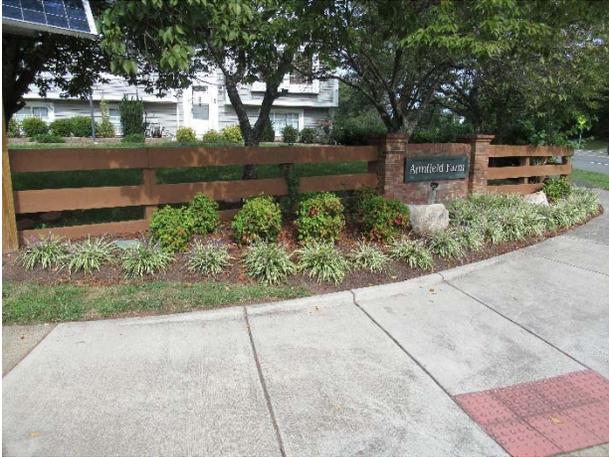
Entrance monument – Note: Bellerose Drive and Lees Corner Road

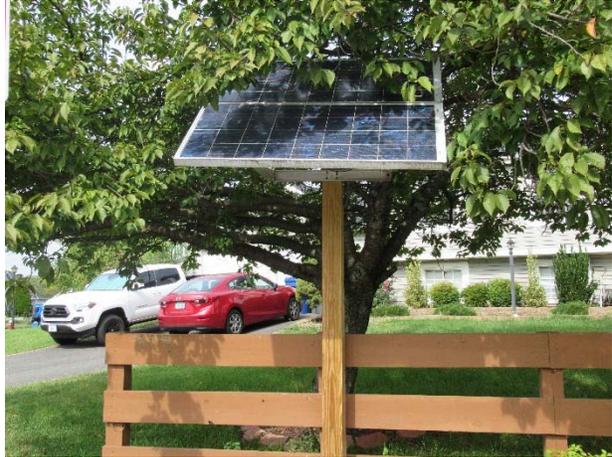
Solar panel – Note: Bellerose Drive and Lees Corner Road

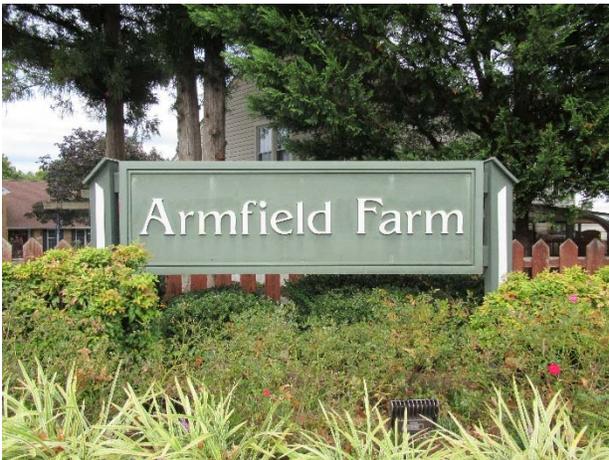
Signage – Note: Bokel Drive and Lees Corner Road

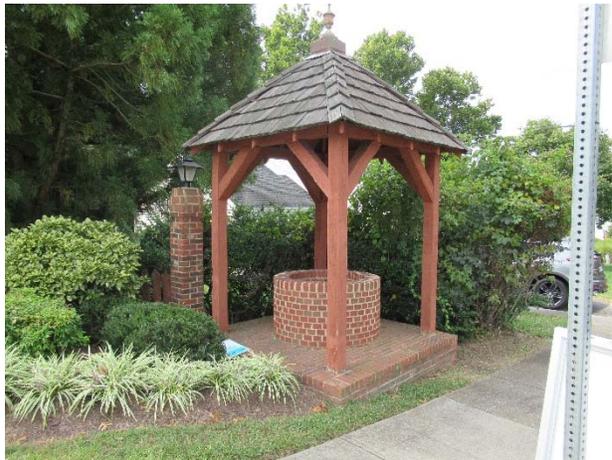
Well Structure – Note: Bokel Drive and Lees Corner Road

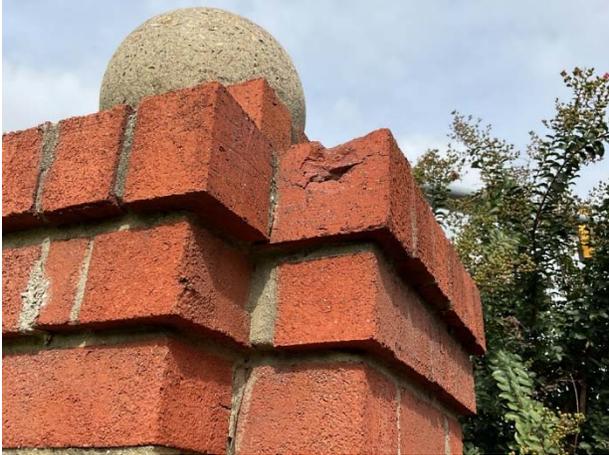
Masonry damage – Note: Centerville Road and Armfield Farm Drive

- Annually:
 - Inspect and repair damage, vandalism and loose components
 - Verify lighting is working properly
 - Touch-up paint finish applications if applicable

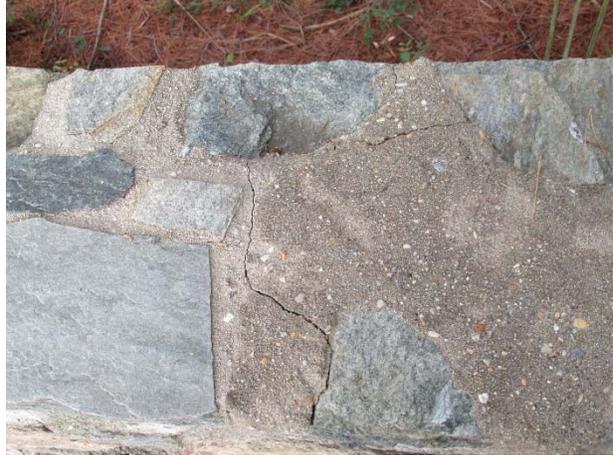
Mortar cracks – Note: Springhaven Drive and Lees Corner Road

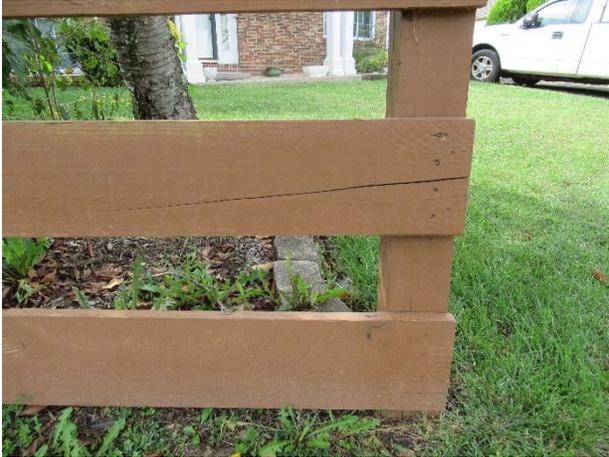
Wood split – Note: Bellerose Drive and Lees Corner Road

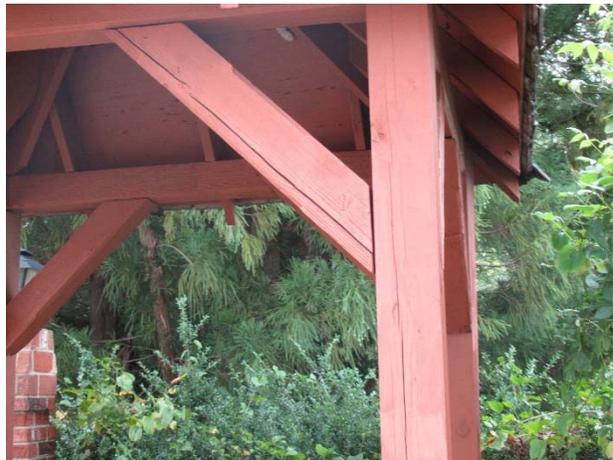
Wood split – Note: Bokel Drive and Lees Corner Road

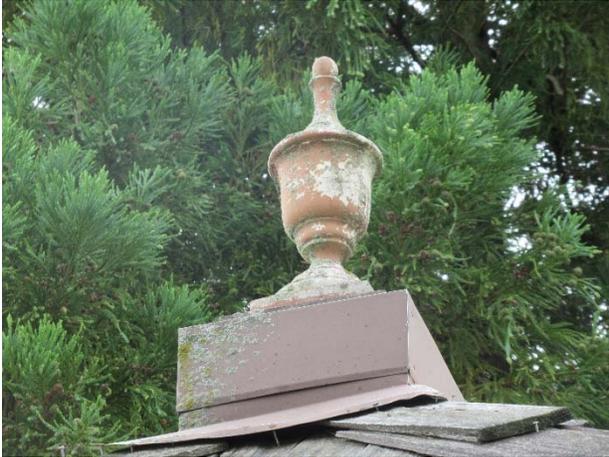
Finish deterioration – *Note: Bokel Drive and Lees Corner Road*

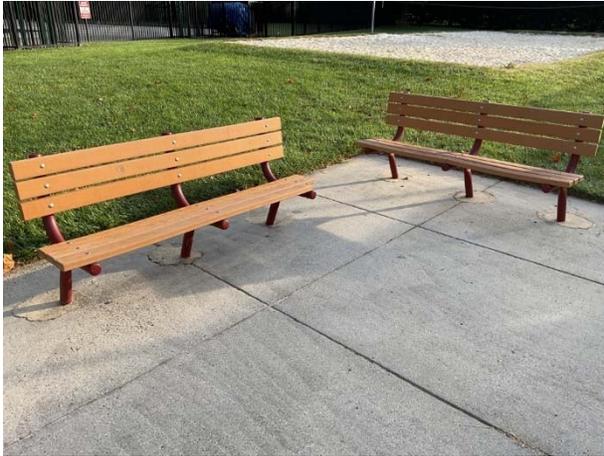
Benches

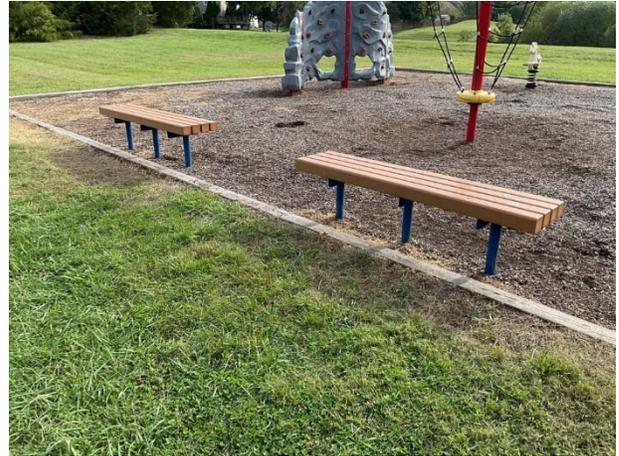
Benches

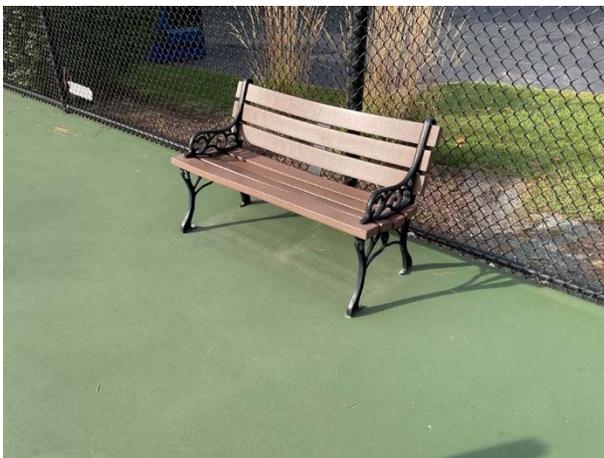
Bench

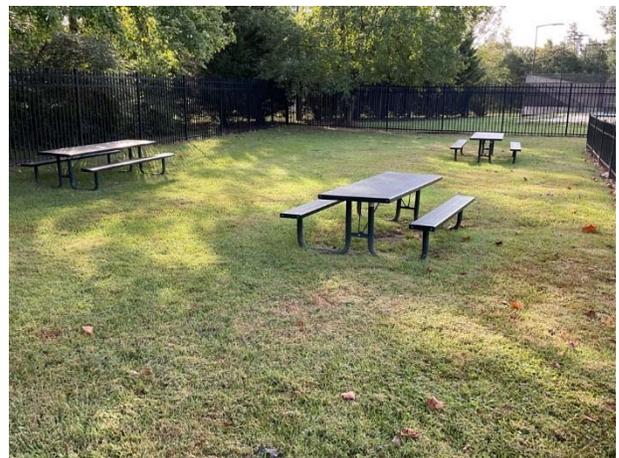
Picnic tables

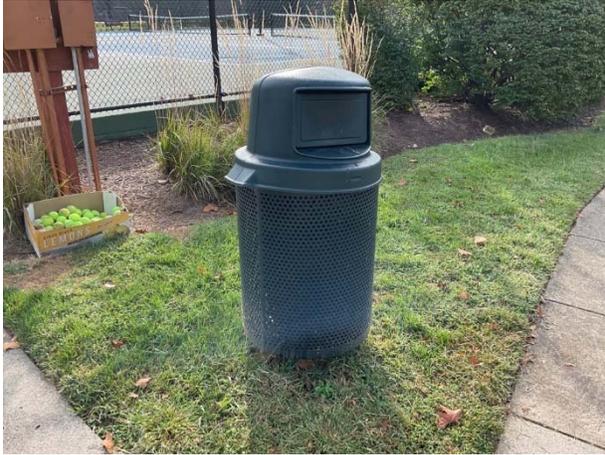
Trash receptacle

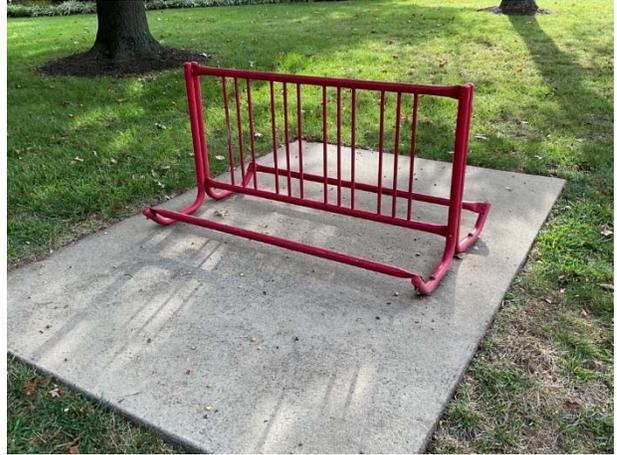
Bicycle rack

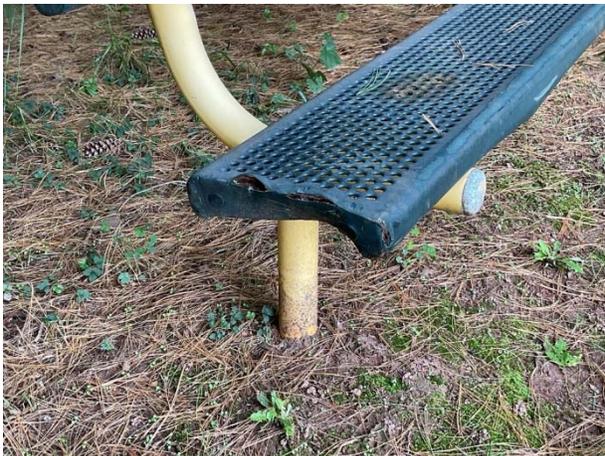
Damage and rust – Note: pool house playground

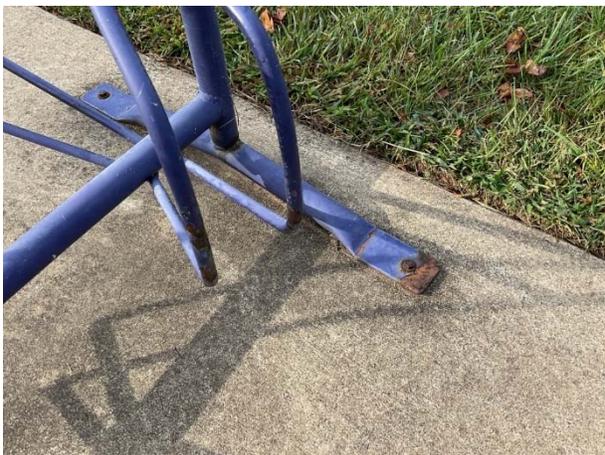
Finish deterioration and rust

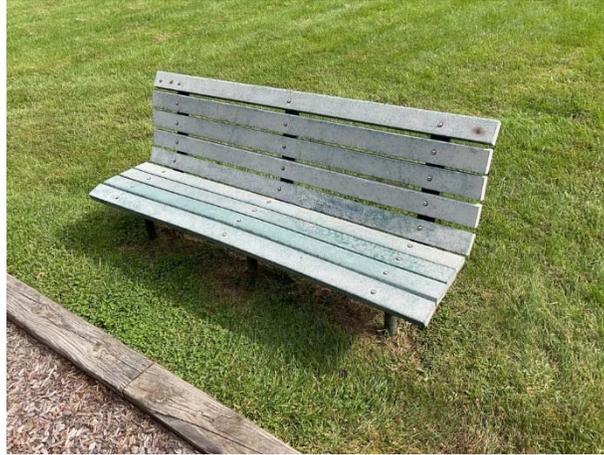
Finish deterioration – *Note: Clary Sage Drive playground*

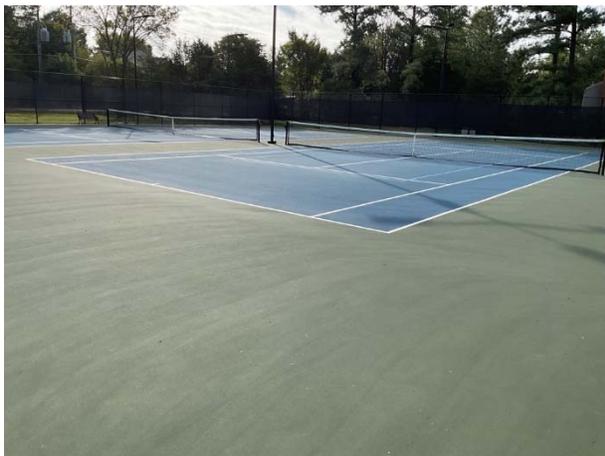
Tennis court overview

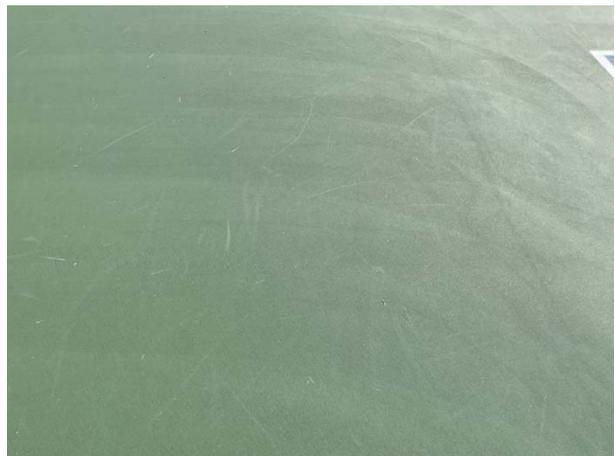
Condition: Good to fair overall with scuffs evident.

Scuffs

Component Detail Notes: Prior to the application of the color coat, the Association should require the contractor to rout and fill all cracks with hot emulsion. This deters water infiltration and further deterioration of the asphalt playing surface.

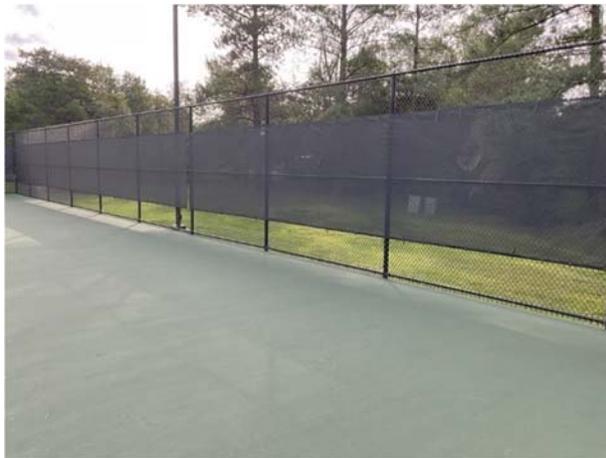
Fence and windscreen overview

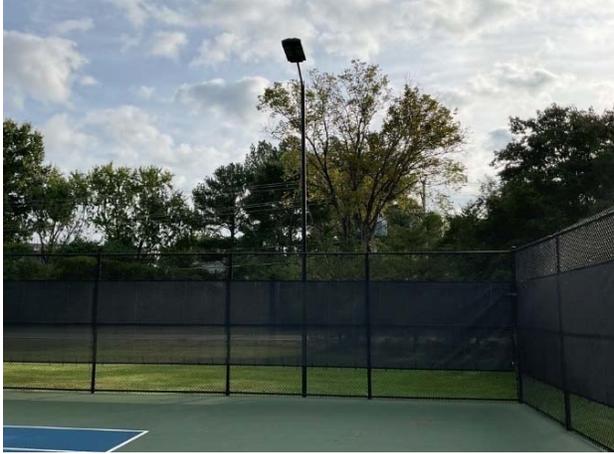
Light pole and fixture overview

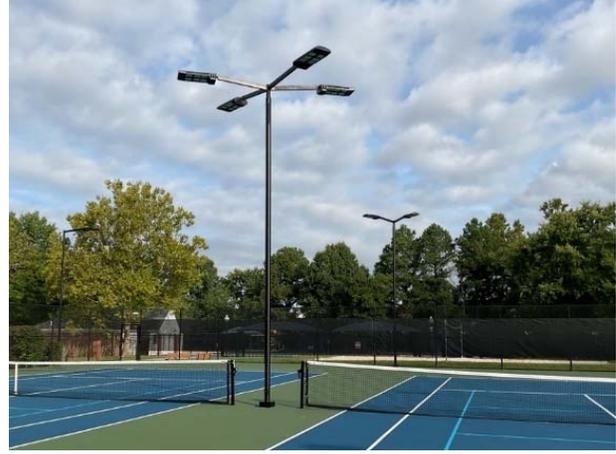
Light pole and fixture overview

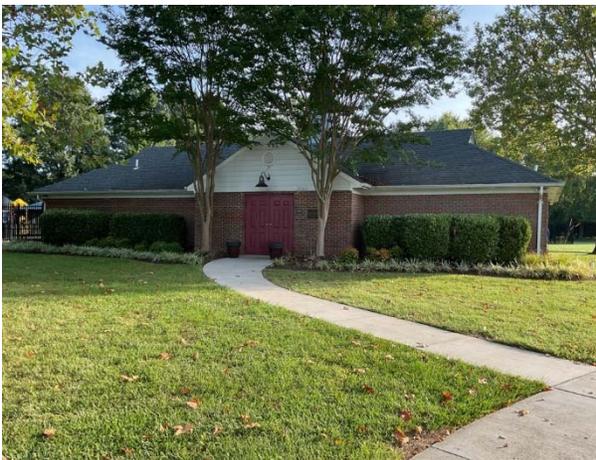
Pool house front elevation overview

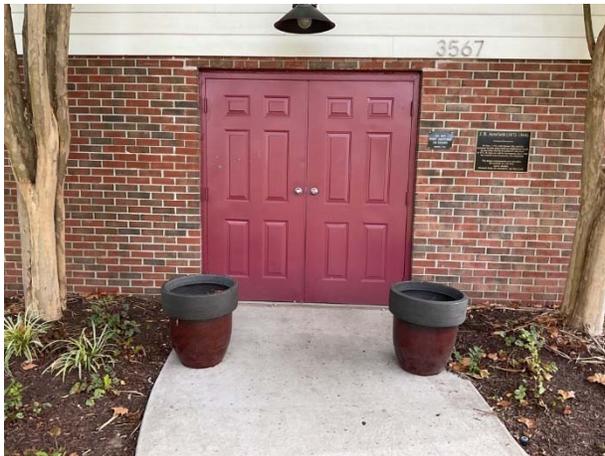
Front entrance door

Condition: Varying from good to fair overall with rust evident at the rear entrance doors.

- Annually:
 - Inspect and repair any damage, base corrosion or alignment issues
 - Replace deteriorated hardware and loose weather stripping
 - Periodic touch-up paint finish applications as needed

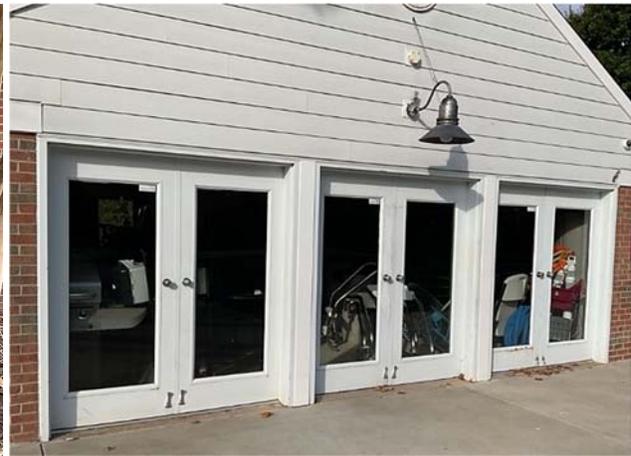
Rear entrance doors

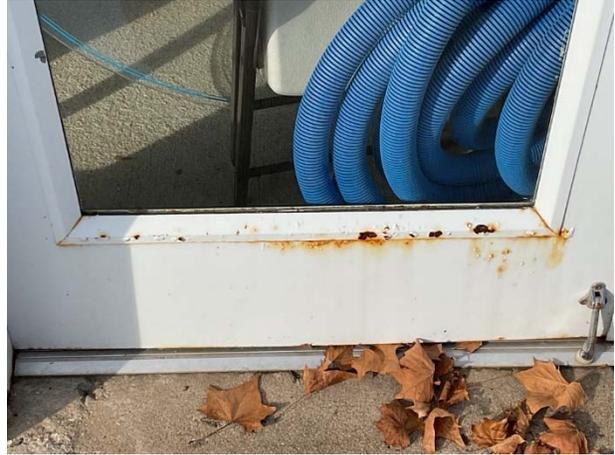
Entrance door rust – Note: rear entrance door

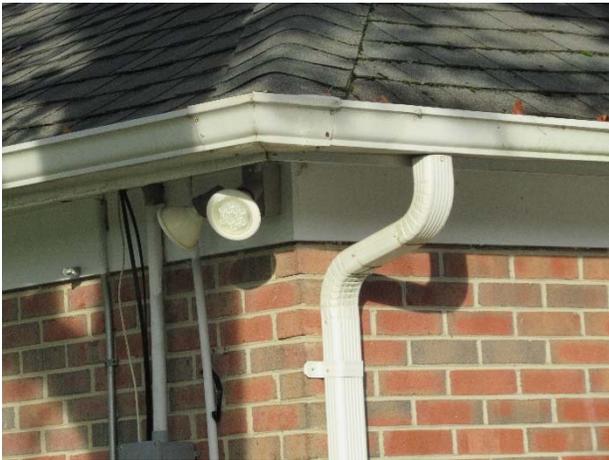
Condition: Good to fair overall with damaged gutters evident.

Gutter and downspout overview

- Semi-annually:
 - Clean out debris and leaves that collect in the gutters
 - Repair and refasten any loose gutter fasteners
 - Repair and seal any leaking seams or end caps
 - Verify downspouts discharge away from foundations

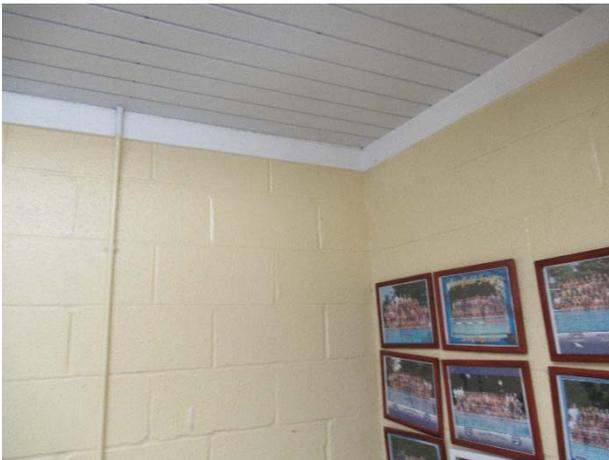
Condition: Good to fair overall with paint deterioration evident.

Paint application overview

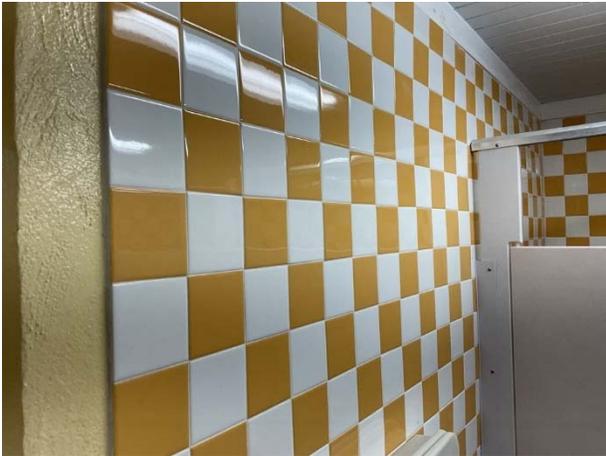
Condition: Good to fair overall with mold and rust evident.

Tile overview

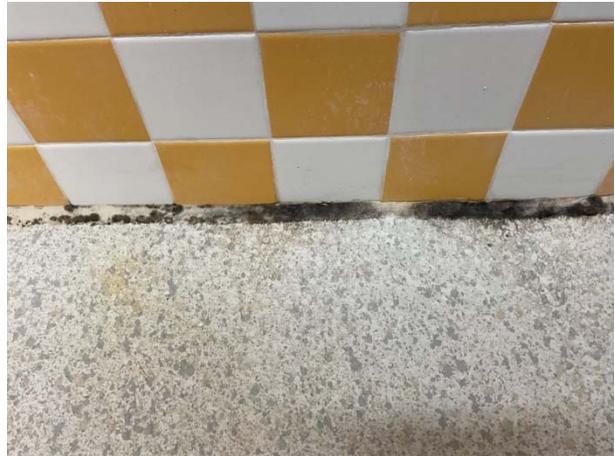
Mold

We recommend budgeting for cleaning the mold through the operating budget.

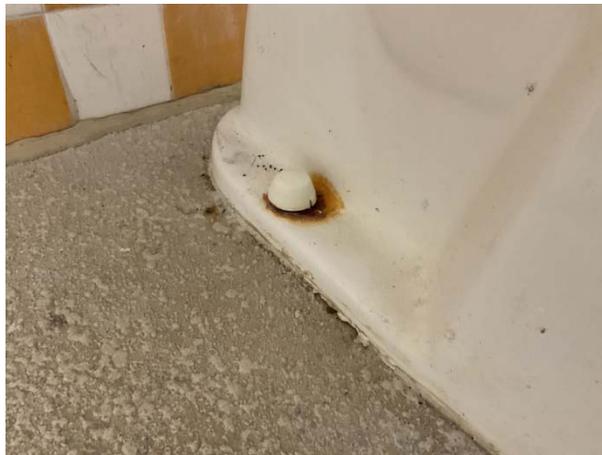
Rust
