Armfield Farm

Homeowners Association

September 20, 2023 • Chantilly, VA

RESERVE STUDY

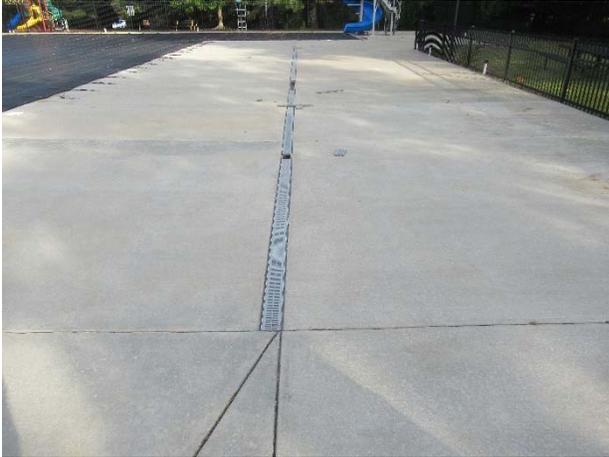
Condition: Good to fair overall with isolated cracks evident.

Concrete deck overview

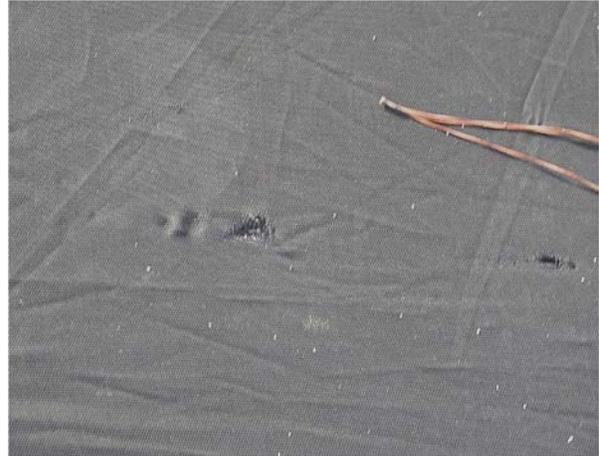
Condition: Good to fair overall with tears evident.

Cover tears – Note: main pool

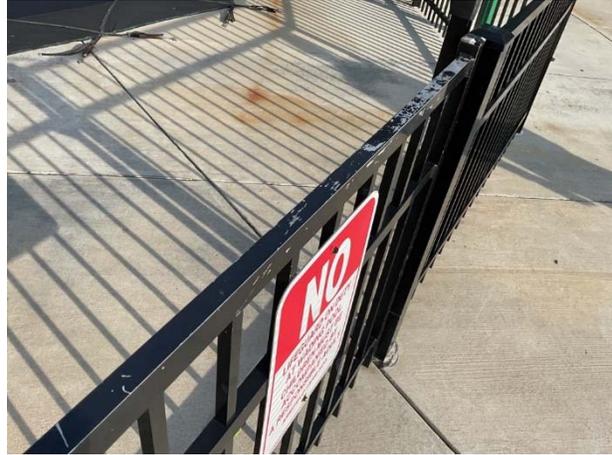
Condition: Good to fair overall with finish deterioration evident.

Finish deterioration

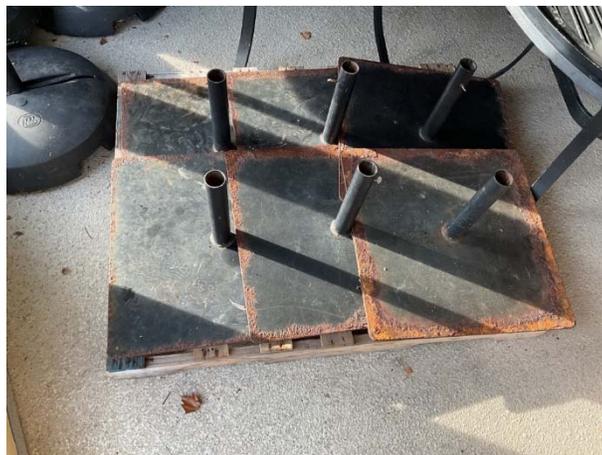
Condition: Varying from good to fair overall with finish deterioration and rust evident.

Umbrella base rust

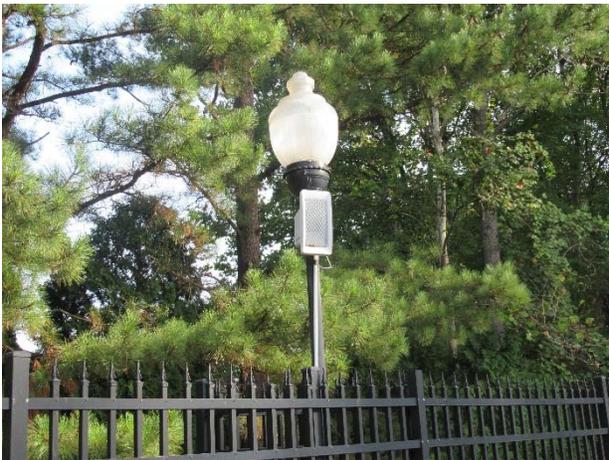
Condition: Fair overall with finish deterioration and rust evident.

Light pole and fixture overview

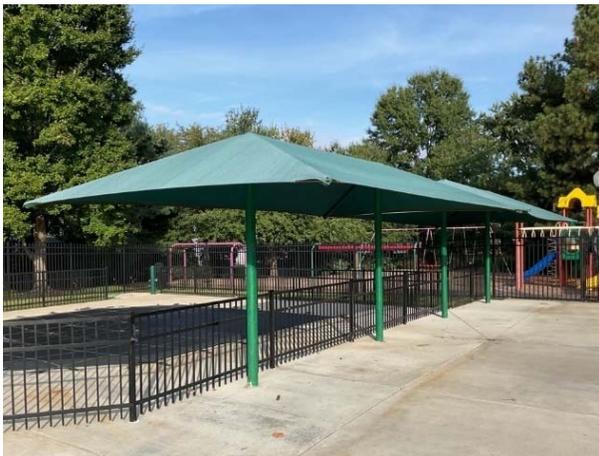
Condition: The structures at the wading pool is in fair overall condition with finish deterioration and rust evident. The structure at the main pool is in good to fair overall condition.

Shade structure overview – Note: wading pool

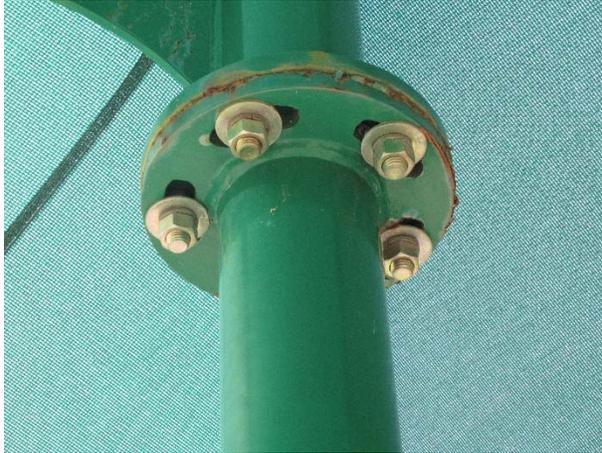
Rust – Note: wading pool

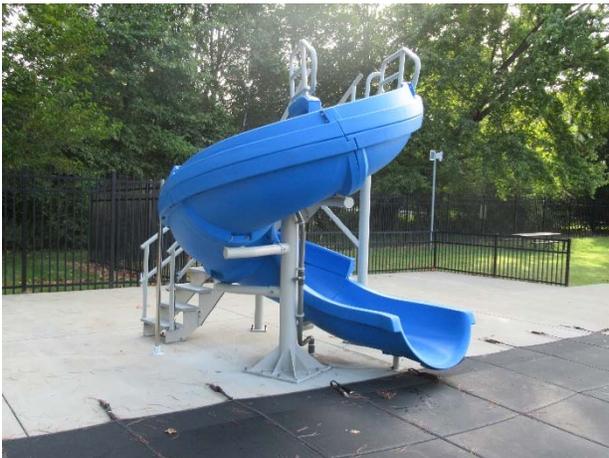
Conditions: Good to fair overall with base rust evident.

Water slide overview

Component Detail Notes: Safety is the major purpose for maintaining the water slide. We recommend an annual inspection of the water slide to identify and repair as normal maintenance loose connections and fasteners or damaged elements. We recommend the use of a specialist for the design or replacement of the water slide environment.
